# FULL RESERVE STUDY

## Silver Valley Condominium, Inc.

**Munroe Falls, Ohio**

**April 14, 2016**

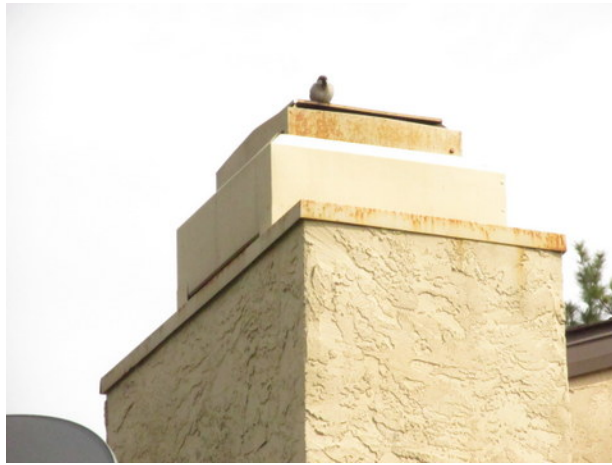
**Chimney Caps, Metal** - Silver Valley maintains 111 metal chimney caps. The Board informs us 44 chimney caps were replaced from 2006 to 2014. These chimney caps are in good to fair condition. The remaining 67 chimney caps are likely original and in fair condition based on our visual inspection from the ground. The Board informs us all chimney caps were visually inspected from 2014 to 2015 and either painted or replaced at this time. We note chimney cap rust.

**Chimney cap rust**

Chimney caps of this type have useful lives of up to 25 years. We recommend the Association anticipate the phased replacement of the 44 chimney caps replaced from 2006 to 2014 beginning by 2030 and concluding by 2038. Based on discussions with the Board and recent repairs, we recommend the Association anticipate the phased replacement of the remaining 67 chimney caps and related flashing beginning in 2017 and concluding by 2020. Subsequent phased replacement is likely beginning by 2041 and concluding by 2044. We depict this information on Line Items 1.140 and 1.180 of *Reserve Expenditures*. When applicable, we recommend the Association inspect the condition of the chimney caps concurrent with replacement of the roof systems.

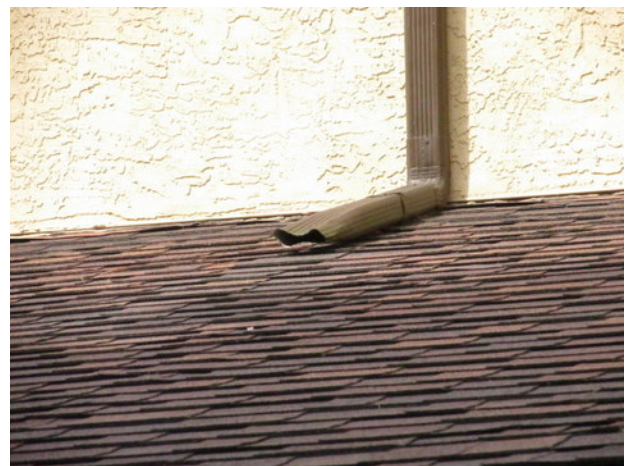
**Gutters and Downspouts, Aluminum** - Approximately 18,000 linear feet of aluminum gutters and downspouts drain storm water from the roofs of Silver Valley. The Board informs us approximately 9,000 linear feet of gutters and downspouts were replaced from 2012 through 2015. These gutters and downspouts are in good to fair overall condition. Approximately 9,000 linear feet of gutters and downspouts are original and in fair condition. The Board informs us the gutters and downspouts were recently inspected and the downspouts were painted in conjunction with stucco paint finish applications. The gutters and downspouts exhibit damage.

**Downspout damage, minor asphalt shingle granular loss and direct downspout discharge onto asphalt shingle roof**

a roof pitch factor and the rainfall intensity number of the Association's region. We recommend sloping gutters 1/16 inch per linear foot and providing fasteners a maximum of every three feet.

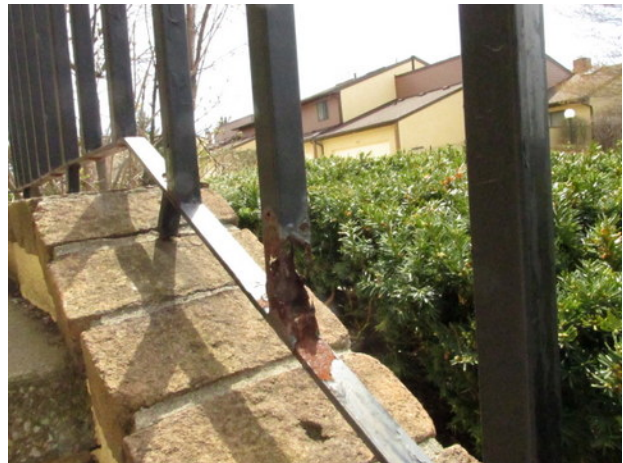
**Railings and Gates, Metal** - The Association maintains approximately 765 linear feet of metal gates and railings at various unit entrances. Approximately 100 linear feet of metal gates and railings were replaced in 2015 or will be replaced in 2016. See “**Staircases**” for our inclusion of this cost. The remaining gates and railings are likely original and in fair condition with isolated sections in poor condition. The gates and railings exhibit rust and paint finish deterioration.

**Significant metal railing rust at Unit 114**

Railings of this type have a useful life of up to 35 years with the benefit of periodic maintenance. Periodic maintenance should include applications of a protective paint finish and partial replacement of deteriorated metal every six- to eight-years.

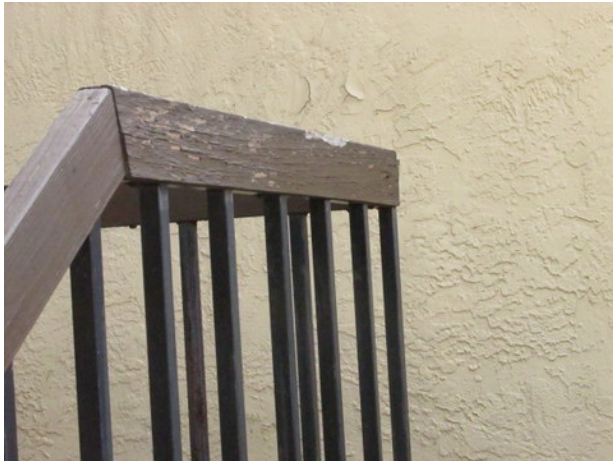
**Wood paint finish deterioration**

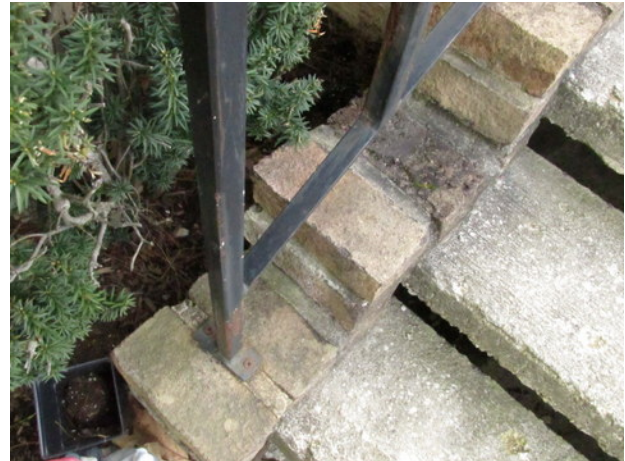
**Typical metal railing rust**

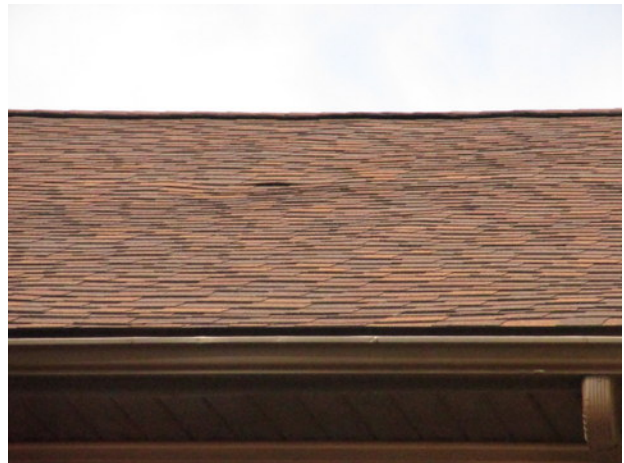
**Roofs, Asphalt Shingles** - Approximately 1,825 *squares*<sup>1</sup> of asphalt shingles comprise the roofs of Silver Valley. The roofs were replaced from 2006 through 2014 and are in good to fair overall condition. Our visual inspection from the ground notes sheathing deflection and asphalt shingle lift.

**Minor shingle lift near Unit 116**

The useful life of asphalt shingle roofs in Munroe Falls is from 15- to 20-years. We include the following solutions and procedures pertaining to the components of an asphalt shingle roof system, times of replacement, recommended method of replacement, and coordination of other related work for the benefit of present and future board members.

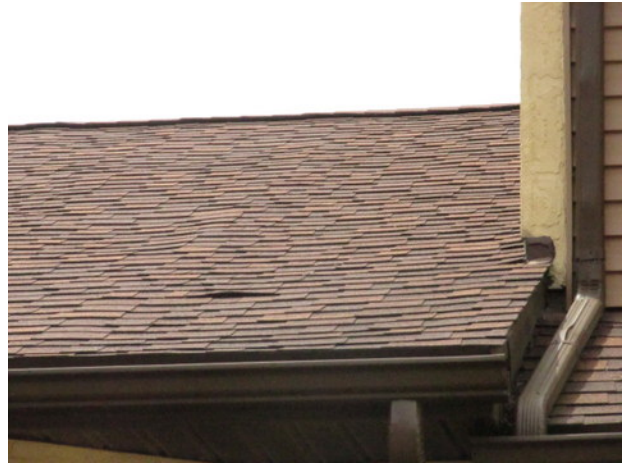
**Minor asphalt shingle lift**

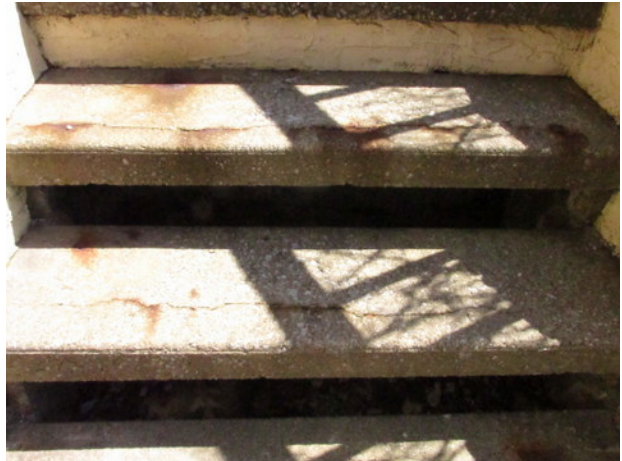
**Staircases** - The Association maintains 28 sets of concrete staircases with decorative brick masonry and metal railings. See “**Railings and Gates, Metal**” for our recommendations on replacement of the metal railings. The staircases are mostly original and in fair overall condition. The Board informs us four staircases were repaired in 2015. The Board also informs us the Association plans to repair or replace concrete treads and railings with deterioration in 2016. We note concrete cracks, concrete deterioration, brick mortar deterioration, organic growth and stucco paint finish deterioration at the staircases.

**Concrete step cracks at Unit 170**

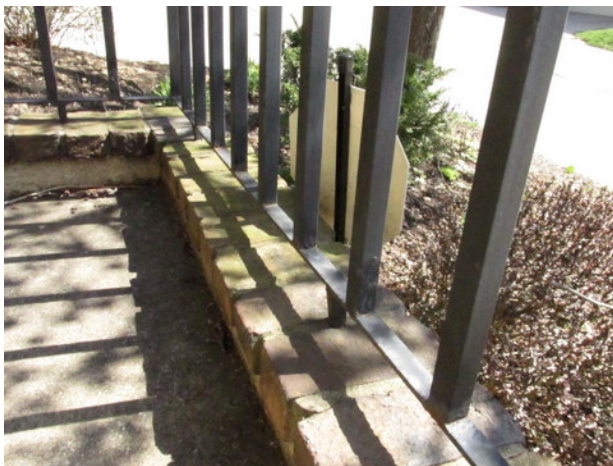
**Decorative brick mortar deterioration and organic growth at Unit 130**

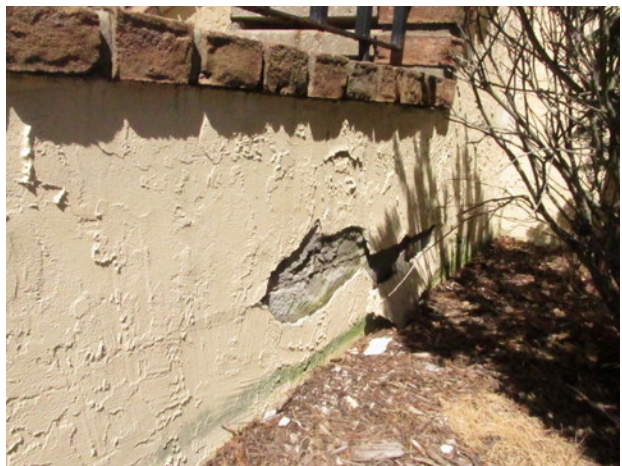
**Stucco paint finish deterioration at concrete staircase at Unit 166**

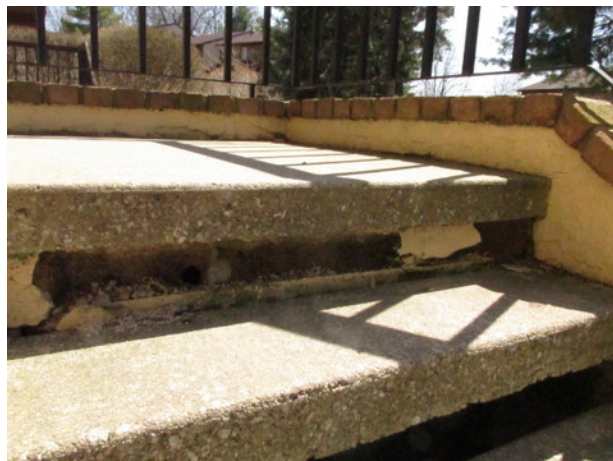
**Concrete and stucco paint finish deterioration near landing at Unit 164**

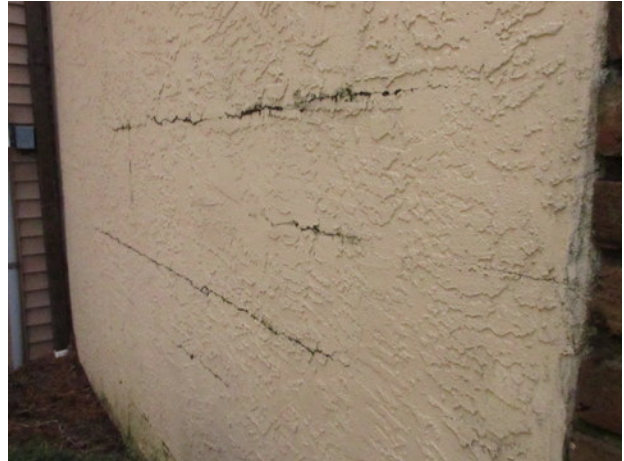
**Walls, Stucco** - Stucco comprises one of the exterior finish materials at the buildings and privacy walls. The stucco is original and in fair overall condition. The Board informs us the stucco paint finish at the buildings was reapplied from 2011 to 2014 and it is in good to fair overall condition. We note stucco cracks, deterioration and paint finish deterioration.

**Stucco cracks at Building 10**

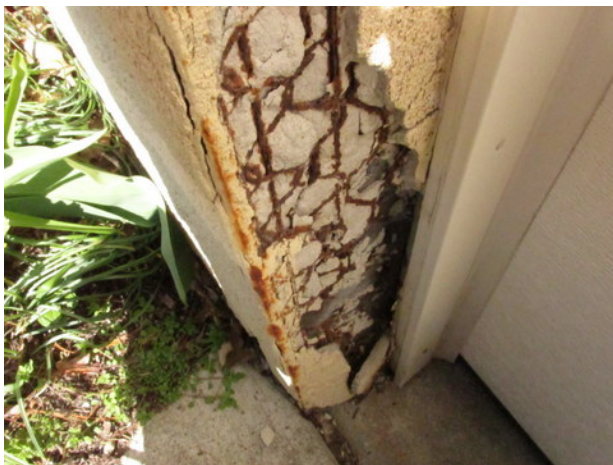
**Stucco deterioration near garage door at Unit 70**

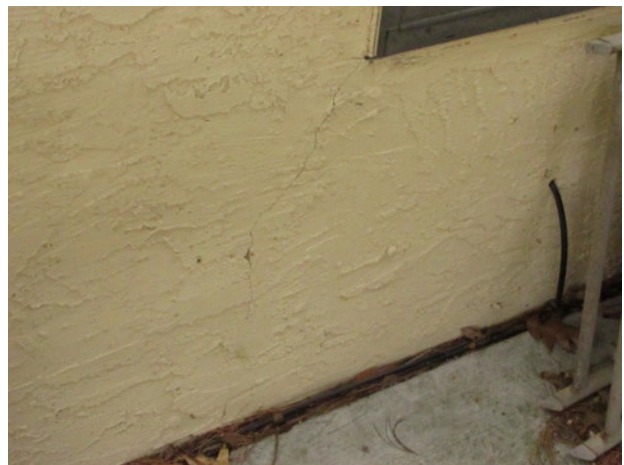
**Stucco crack**

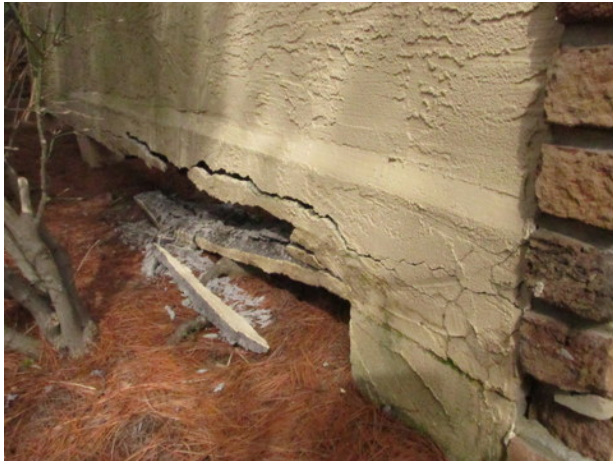
**Significant stucco deterioration and cracks at free standing wall near Unit 106**

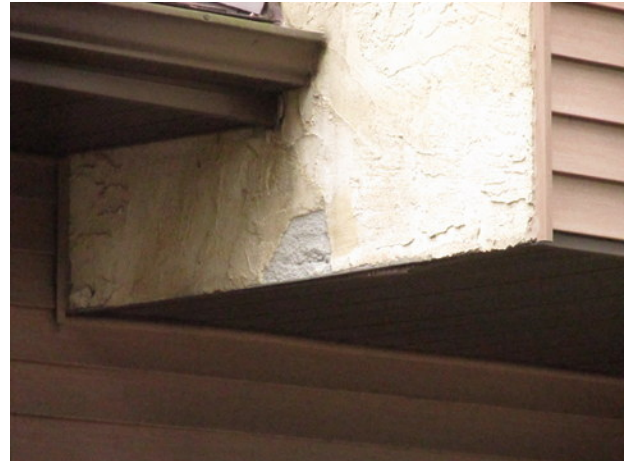
**Stucco paint finish deterioration near Unit 76**

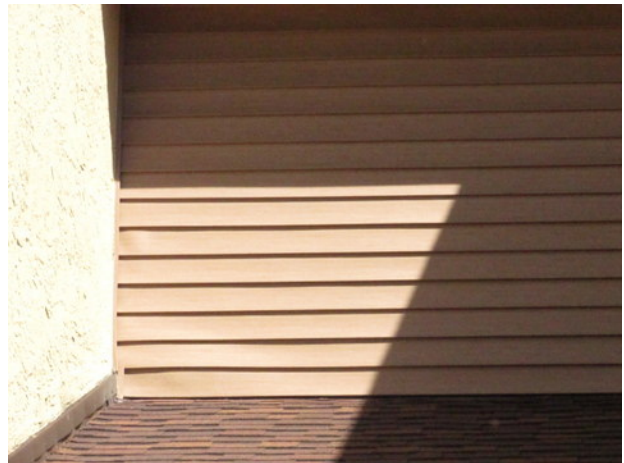
**Walls, Vinyl Siding** - Vinyl siding comprises approximately 77,000 square feet of the exterior walls. This quantity includes the aluminum soffit and fascia. The Board informs us the vinyl siding was installed from 2004 to 2005 and it is in good to fair overall condition. We note vinyl siding solar warp and heat warp adjacent to windows and skylights.

**Vinyl siding warp at Unit 70**

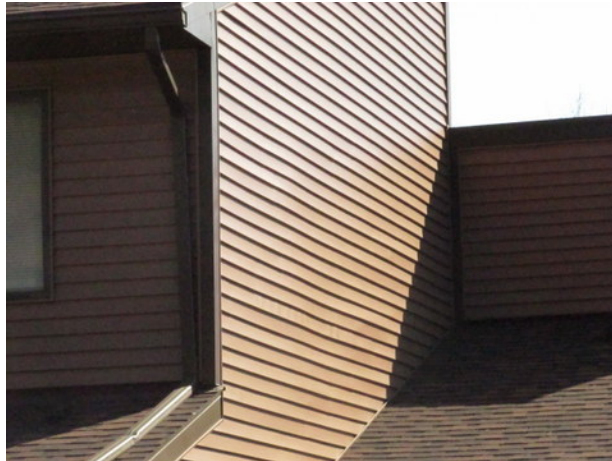
**Vinyl siding warp at Unit 131**

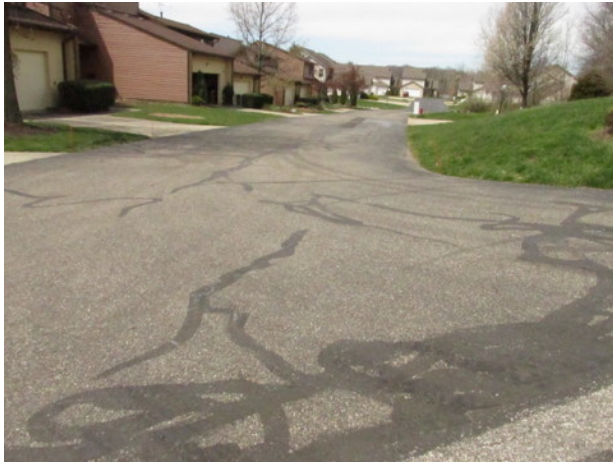
The pavement is in poor overall condition at an unknown age. The Board informs us the Association conducted pavement repairs in 2014. The Association should continue to fund crack repairs and patching as ongoing maintenance through the operating budget. We note cracks, previous repairs, partial replacements and minor catch basin settlement.

**Asphalt pavement street with cracks and previous repairs**

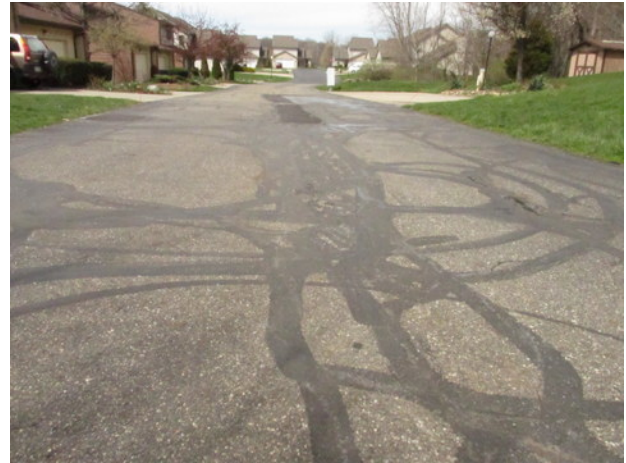
**Asphalt pavement street cracks and previous repairs**

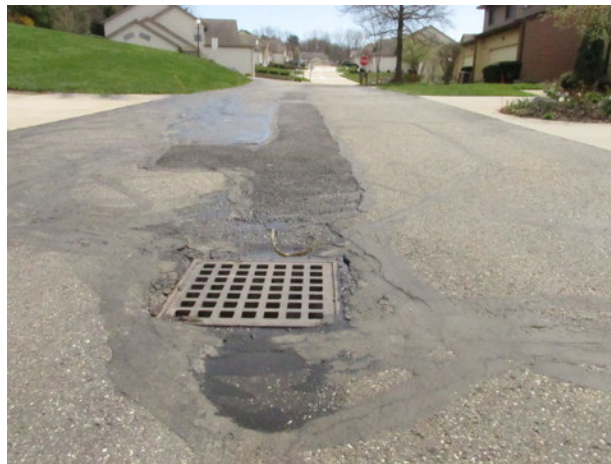
**Asphalt pavement street partial replacements and minor catch basin settlement**

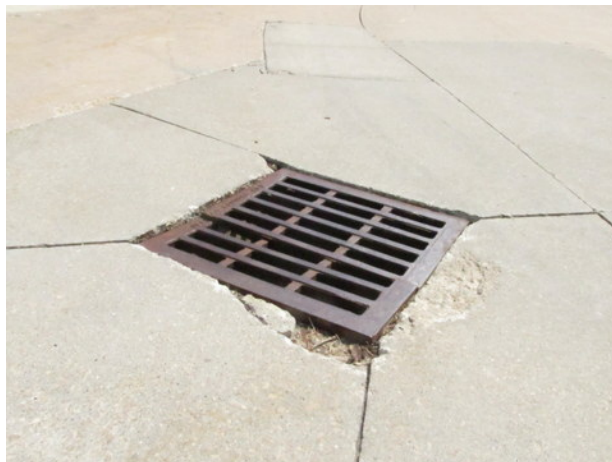
**Catch Basins** - The 20 catch basins collect storm water from the streets and conduct it into the storm water system. The overall condition of the catch basins is fair with minor settlement visually apparent.

**Catch basin with minor settlement**

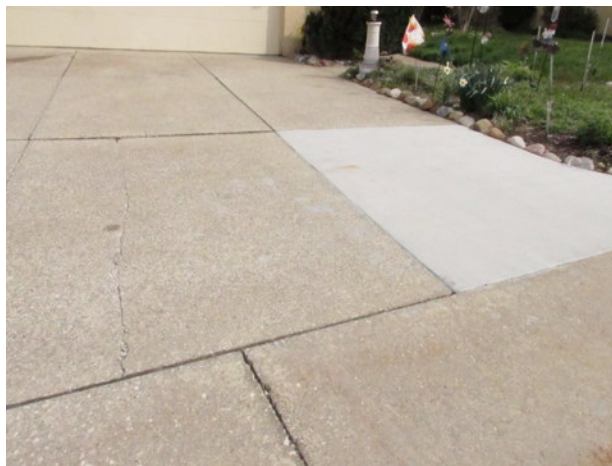
*Concrete Driveways* - Concrete driveways of varying sizes and configurations allow for access to the individual residences throughout the Association. The driveways are in fair overall condition and comprise approximately 38,700 square feet. We note cracks, settlement and partial replacements.

**Concrete driveway cracks and partial replacements near Unit 86**

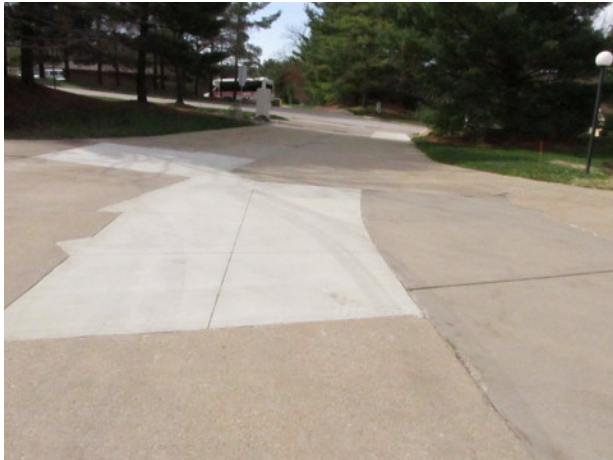
*Concrete Streets* - The Association maintains approximately 75,500 square feet of concrete at the private streets. The streets are mostly original and in fair overall condition. The Board informs us the Association conducted partial replacement events in 2014 and 2015. In addition, the Board informs us the Association plans to replace all remaining areas with significant deterioration in 2016 and 2017. We note cracks, deterioration, settlement and partial replacements.

**Concrete street partial replacements**

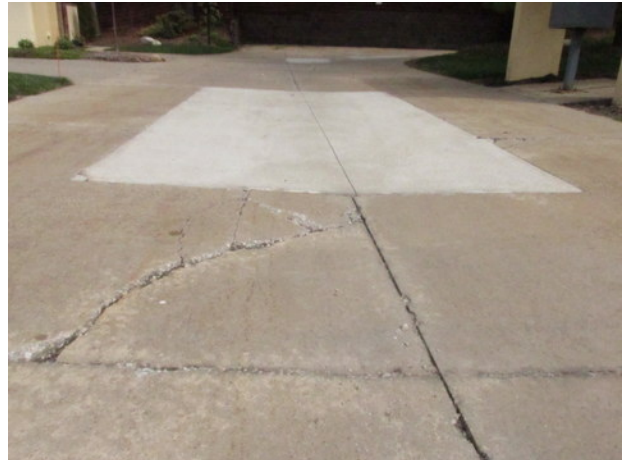
**Concrete street cracks, deterioration and partial replacements**

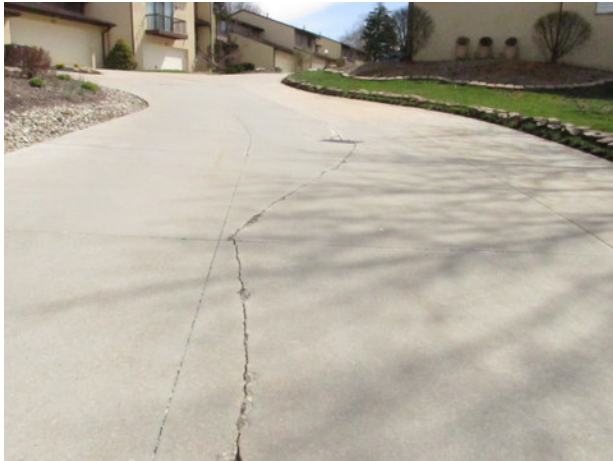
**Concrete street cracks**

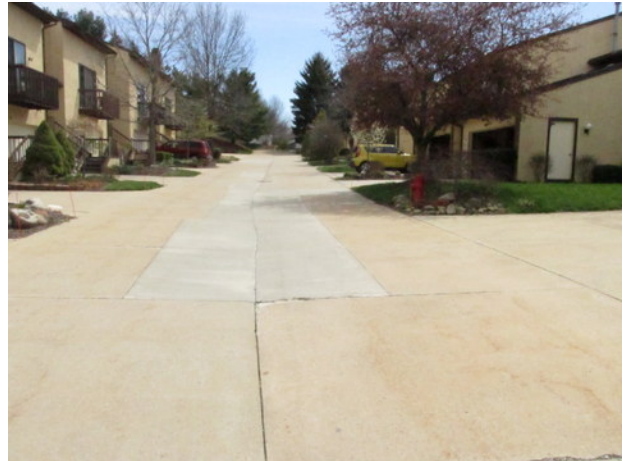
**Concrete street partial replacements**

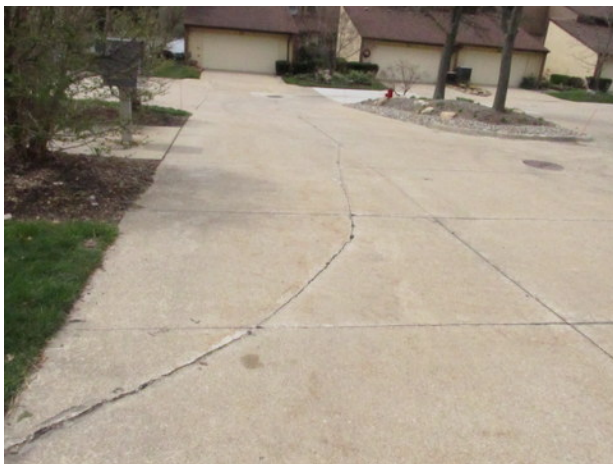
**Concrete street cracks**

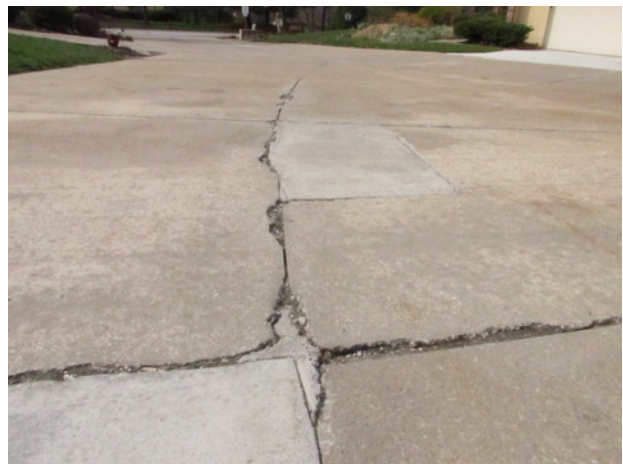
**Concrete street settlement, cracks, deterioration and partial replacements**

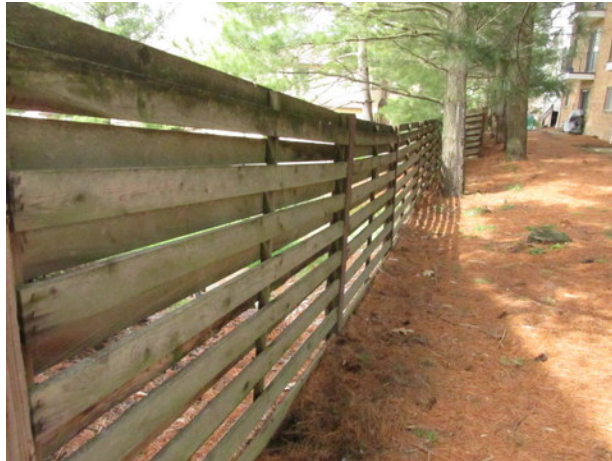
**Fence, Wood** - Approximately 210 linear feet of wood fence line the north perimeter of the property adjacent to Buildings 3 and 4. The wood fence is in good to fair condition at an age of approximately eight years. The Board informs us the Association plans to stain the fence in 2016 and fund this activity through the operating budget. We note minor organic growth.

**Wood fence with minor organic growth**

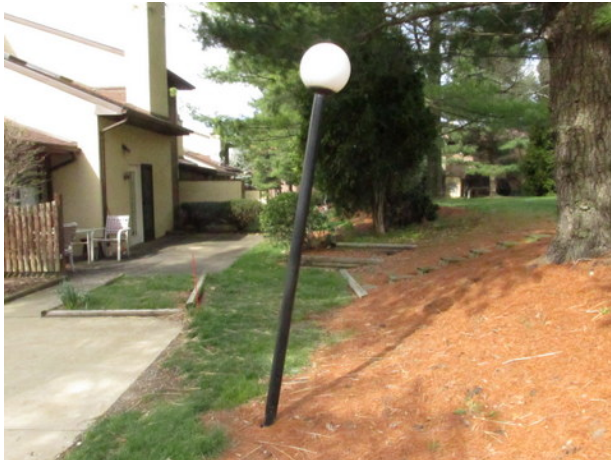
**Light Poles and Fixtures** - The Association uses 31 light poles and fixtures to illuminate the property. These elements are in fair overall condition at an unknown age. The Board informs us the Association plans to clean and paint the light poles in 2017 and fund these activities through the operating budget. We note light pole lean and rust.

**Light pole and fixture with lean**

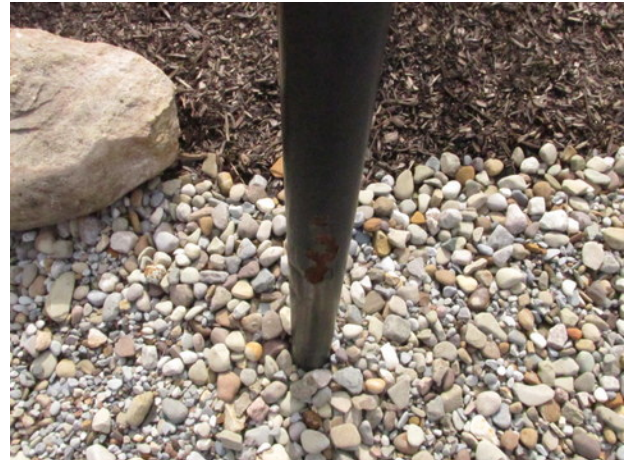
**Light pole rust**

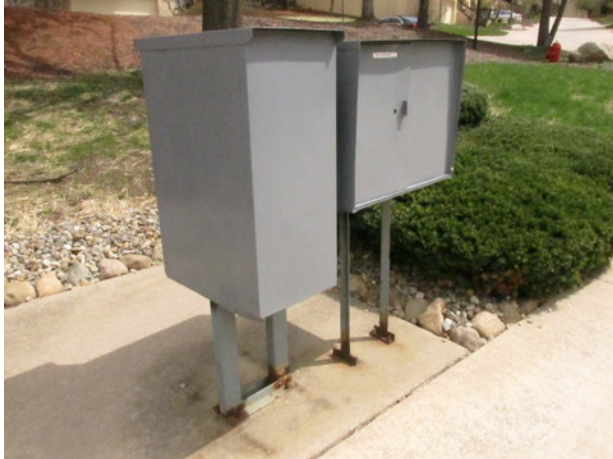
painted in 2014 and these activities were funded through the operating budget. We note mailbox station rust.

**Mailbox station rust**

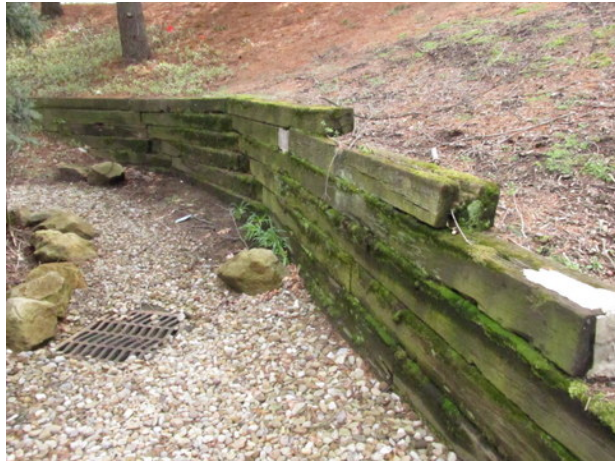
**Retaining Walls, Timber** - The Association maintains retaining walls throughout the property which comprise approximately 2,970 square feet of wood timbers. The Board informs us three retaining walls were removed within the last two years and the landscape at these locations was regraded and mulched as a low cost alternative. The remaining retaining walls are likely original and in fair to poor condition. We note timber retaining wall lean, organic growth, displacement, cracks, rot and damage.

**Typical timber retaining wall with lean and organic growth**

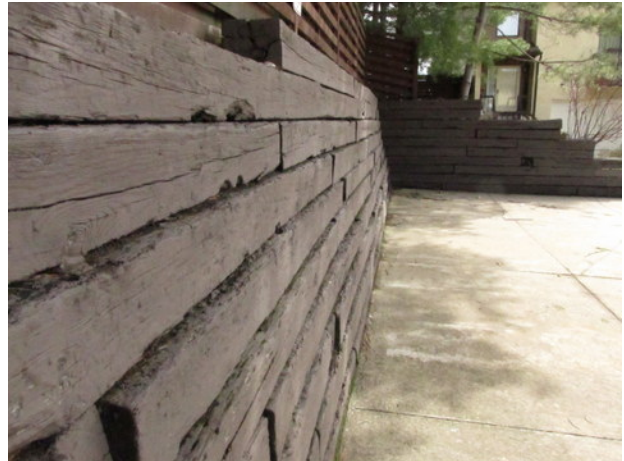
**Retaining wall between Buildings 3 and 4 with cracks and displacement**

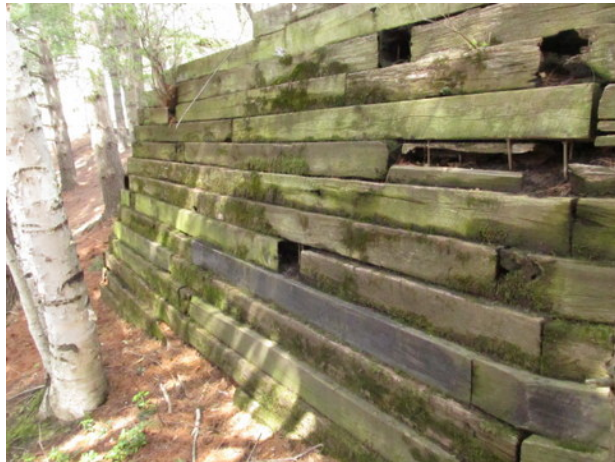
**Timber retaining wall lean, rot, cracks and organic growth**

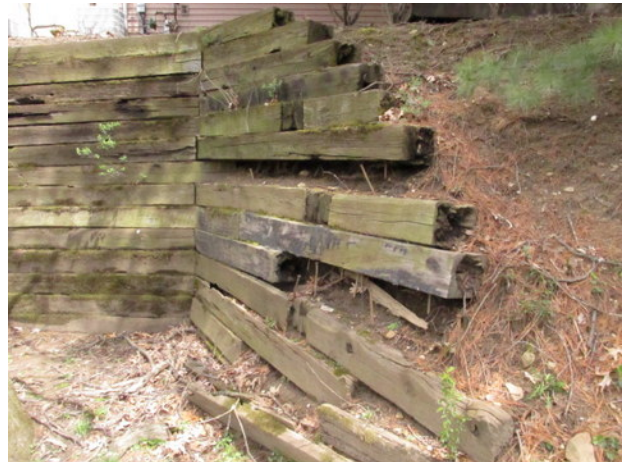
**Timber retaining wall damage, lean, board rot, cracks and organic growth**

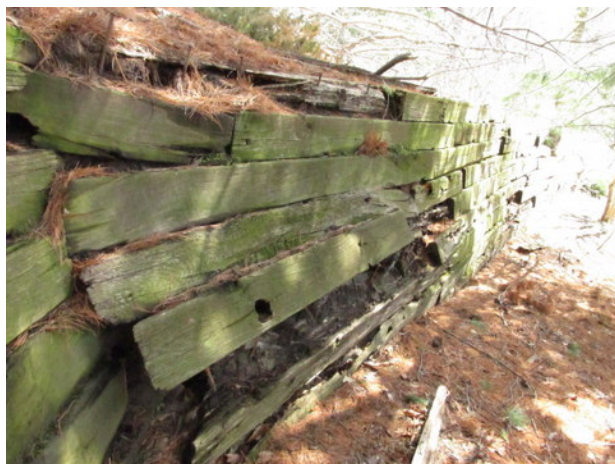
**Timber retaining wall lean, rot, organic growth and cracks**

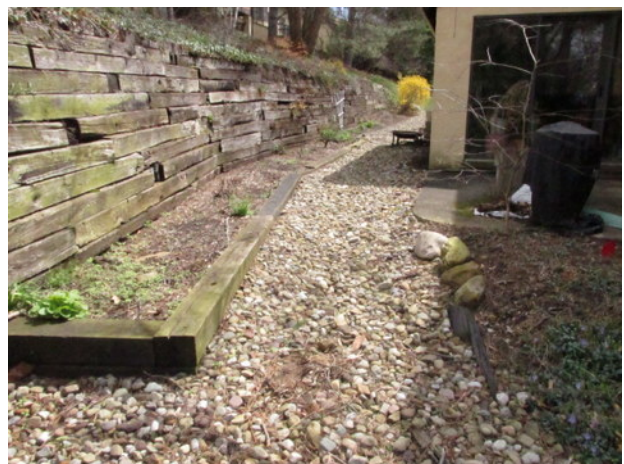
**Timber retaining wall lean, rot, cracks and organic growth**

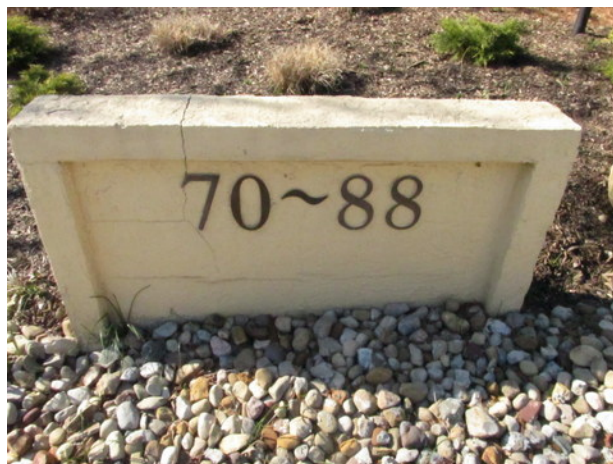
**Concrete unit identification signage with cracks**
