2016 SVCA
ASSET STATUS
for
Reserve Study
Update

This brochure contains supplemental information regarding changes, repairs, and maintenance to the capital assets in our association.

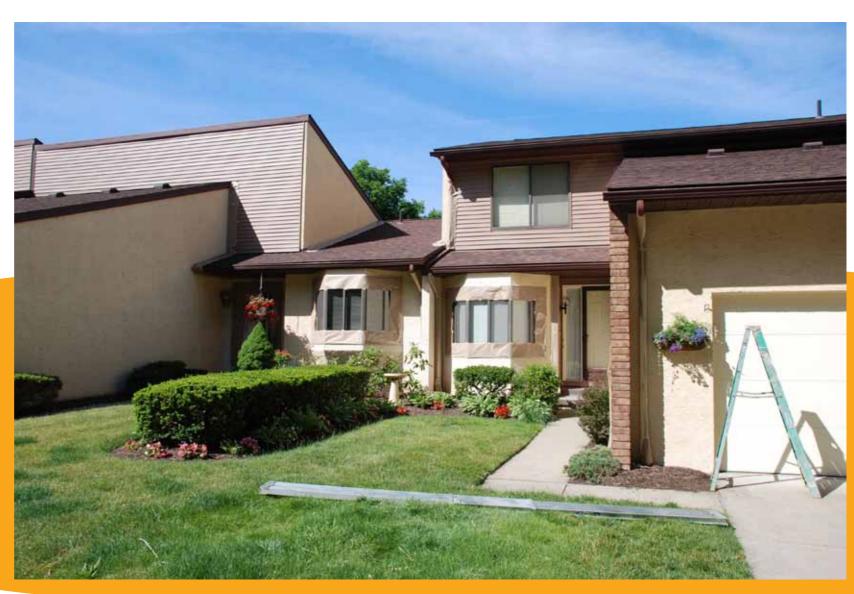
# Painting Completed

All exterior stucco on units was power washed and painted with an epoxy based paint between 2011 and 2014. Improved enforcement of garage and entrance door painting and maintenance.

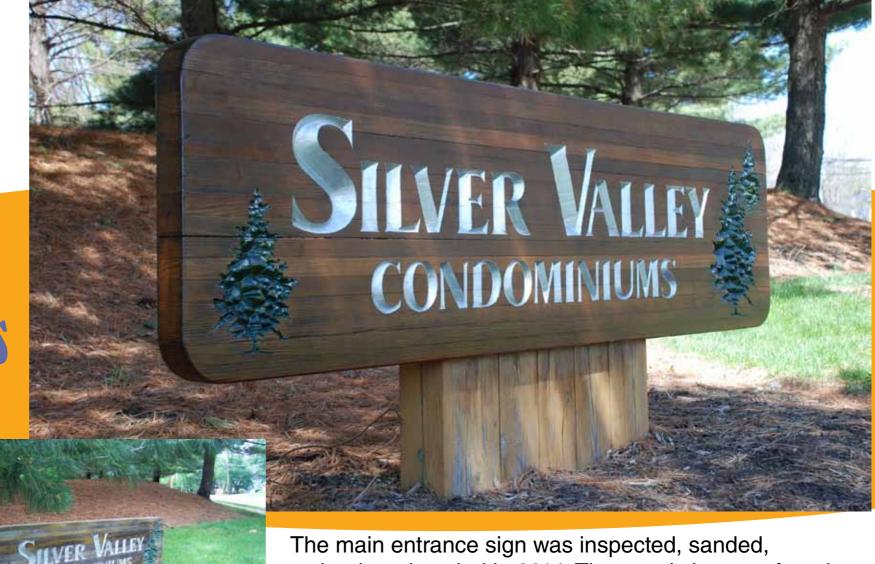
## **Street Entrances**

main entrance sign sanded, painted, and sealed

The main entrance sign was inspected, sanded, stained, and sealed in 2014. The wood sign was found to be structurally sound and serviceable for many years, with continued, periodic maintenance. Same for street entrance signs.

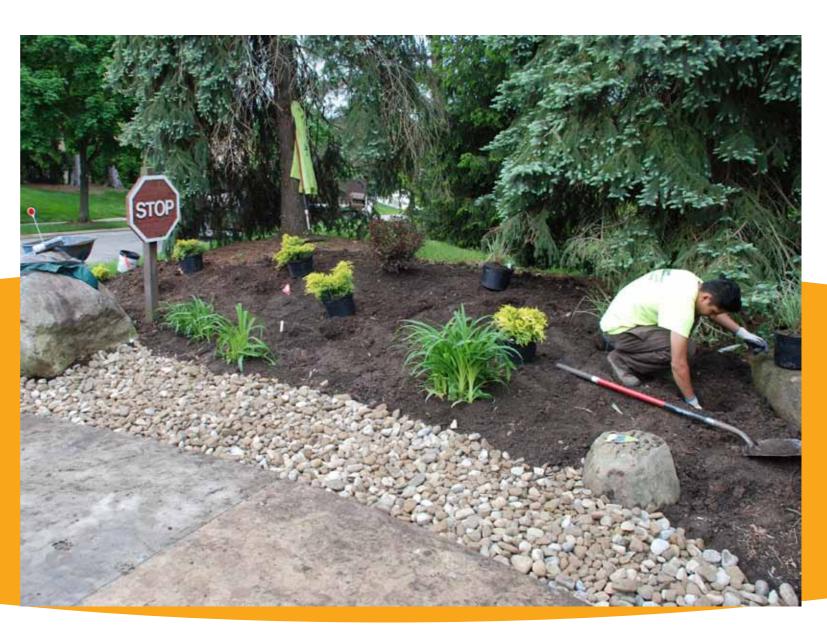
## **Street Entrances**

street entrances cleaned, replanted, and landscaped

A three year contract with our landscape contractor now includes a phased cleaning and re-planting of the three islands in our community. The funding is already built in to the annual budgets for those years.

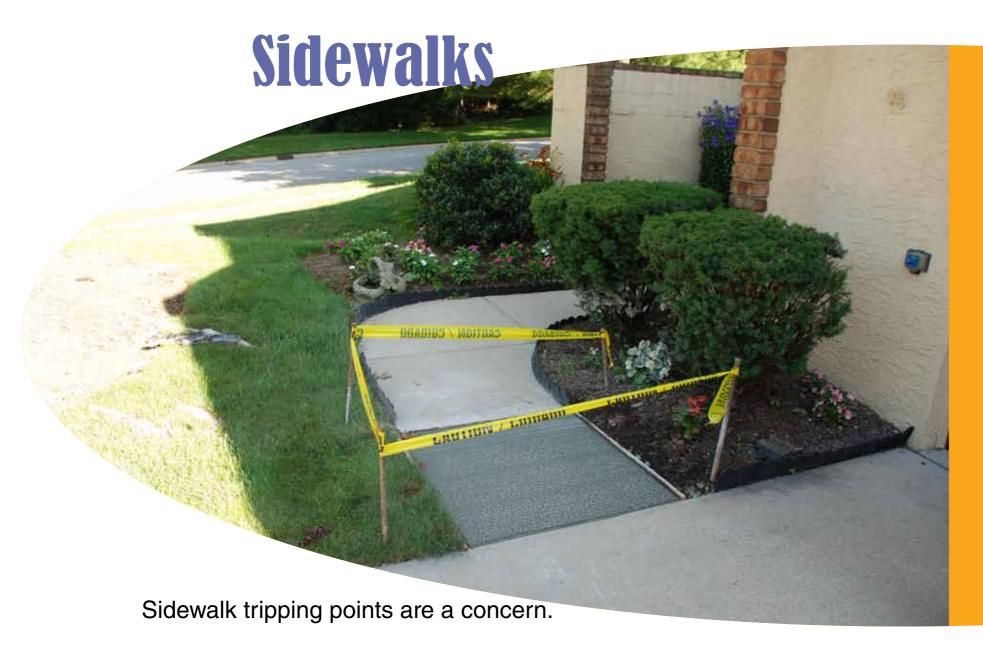
Some sidewalks have already been removed and re-poured; others will be slab jacked to make them level in 2016-17, at an estimated cost of \$3000-5000.

As a result of their recommendations, repair costs to level the sidewalks will be shared by the association (for all sidewalk sections in located common areas), and by individual owners (for repairs of sidewalk sections located in limited common areas). all steel mailboxes and the Olson Spur parking barrier cleaned and painted last year

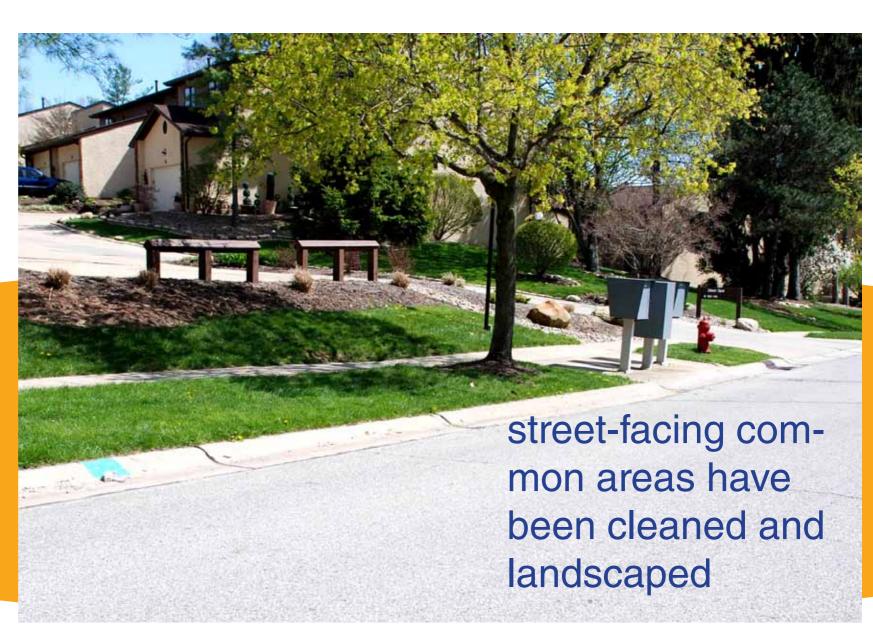
### **Street Entrances**

Mailboxes are still structurally sound. The Board looks to extend the life of our steel mailboxes through periodic maintenance and painting.

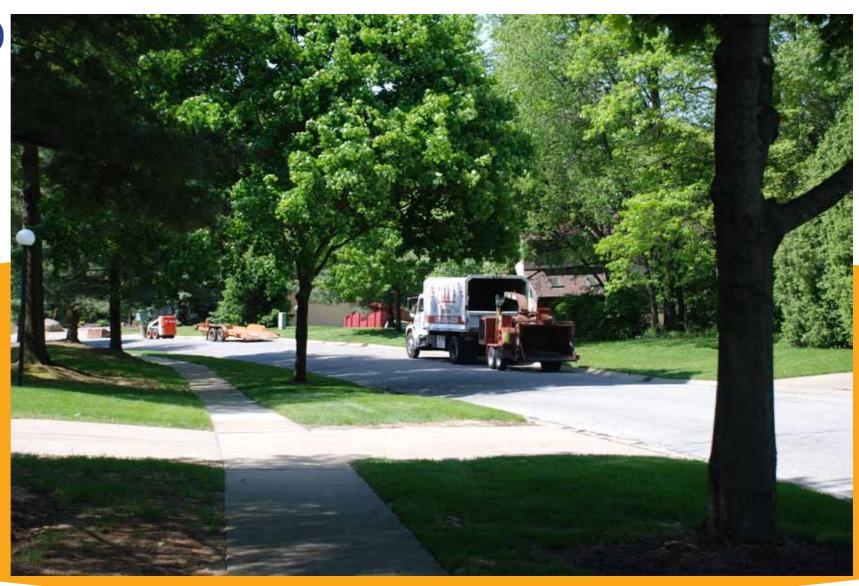
### **Tree Removal**

In 2014-15, over 100 trees were removed that were damaging concrete, roofs, gutters, and building exteriors.

The Board has already budgeted tree service expenses for 2016 to remove additional dead or dying trees. Ongoing maintenance of our heavily treed property is needed to reduce tree-related damage to building roofs, gutters, and exteriors.

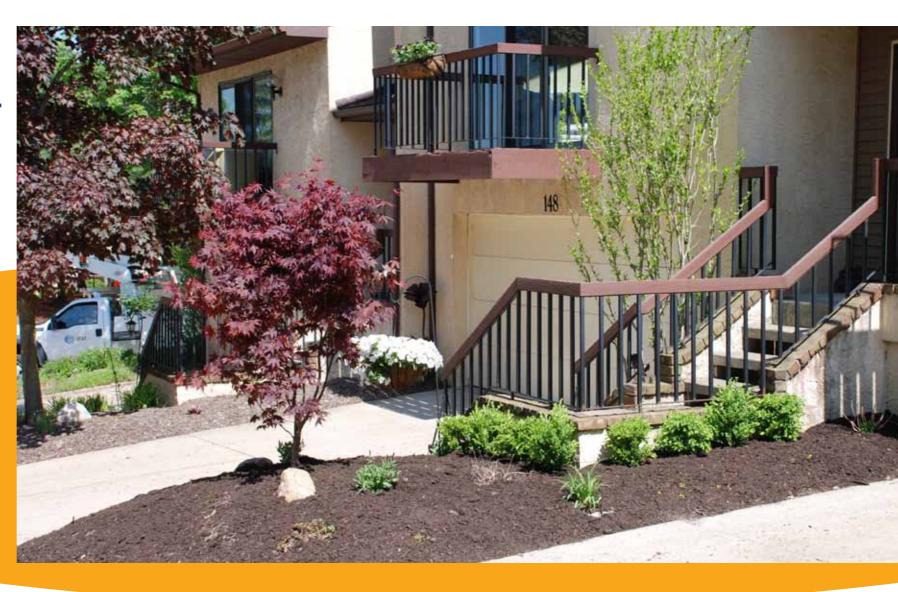
### **Tree Removal**

stumps were ground and smaller trees planted in select areas

We have completed selective replanting using smaller, less damaging ornamental trees in place of much larger trees that were removed in 2014 to prevent continued root heaving and cracking of streets and driveways.

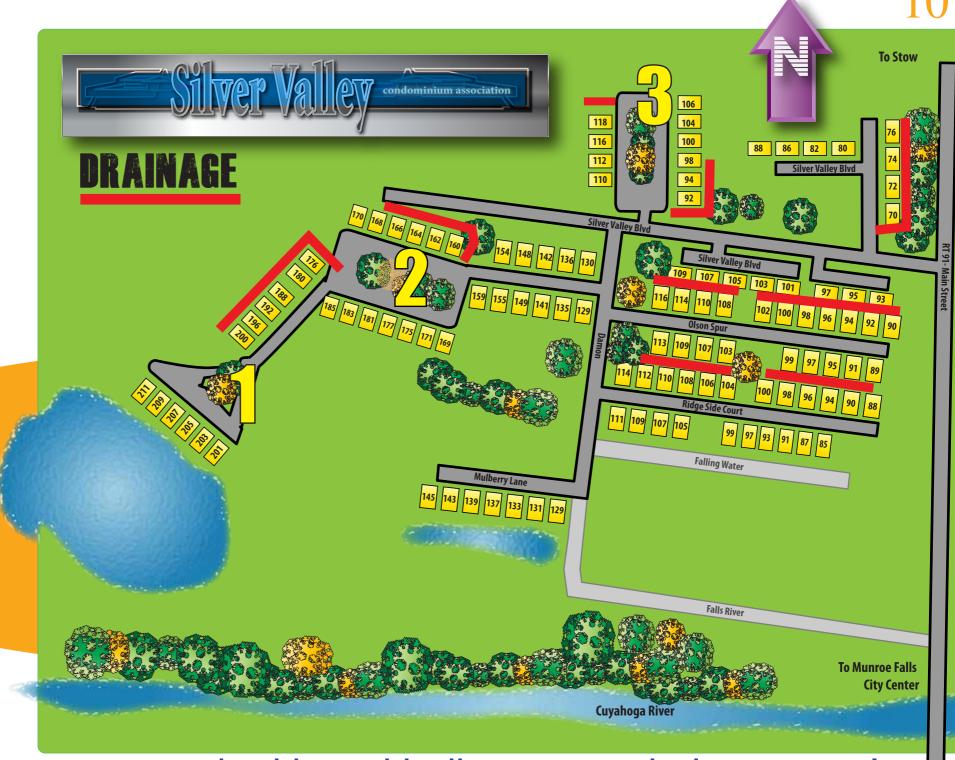
Drainage

As a part of the 2014-15 capital repairs project, stone-lined drainage swales were added to divert stormwater runoff away from units, and to better direct the flow to main drains.

areas marked in red indicate new drainage swales

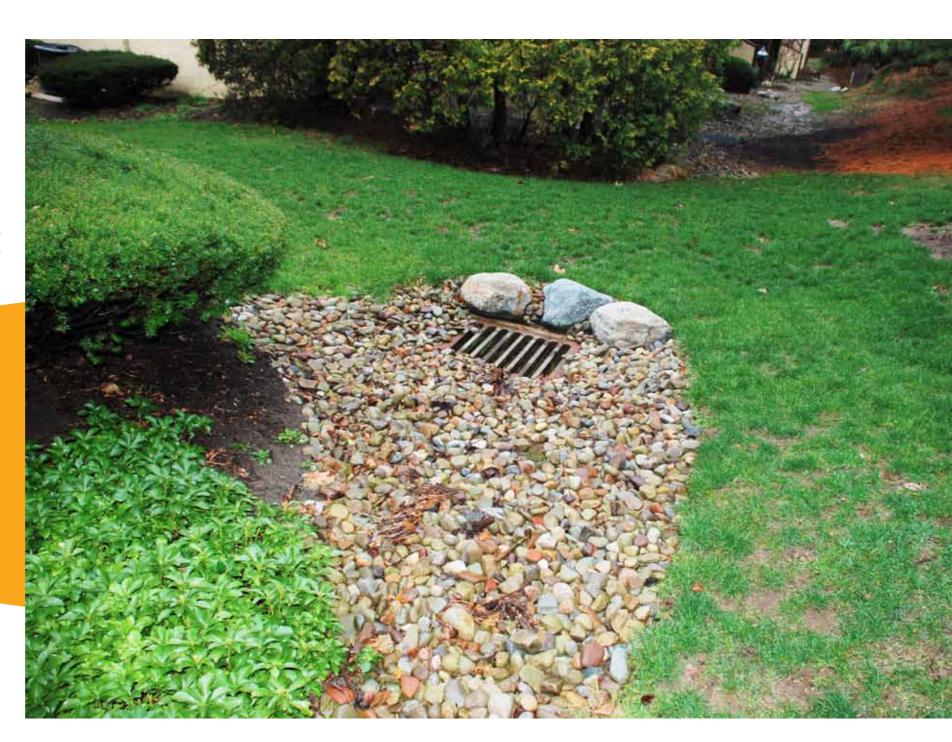
# Drainage

In addition to better directing stormwater with drainage swales, we have cleaned several drain pipes and catch basins.

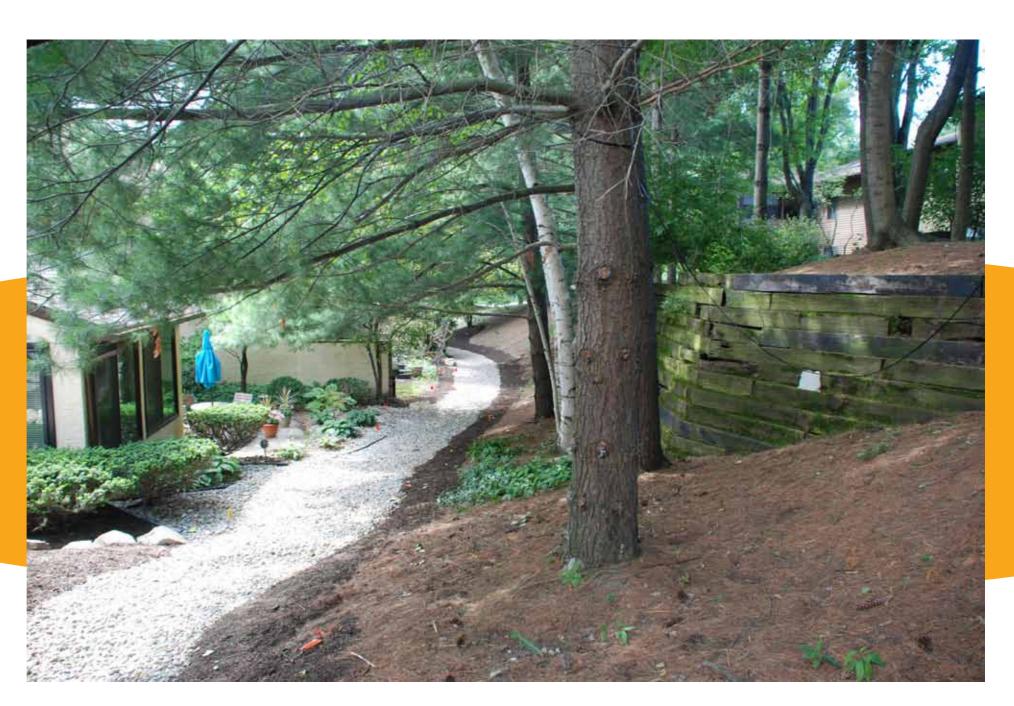
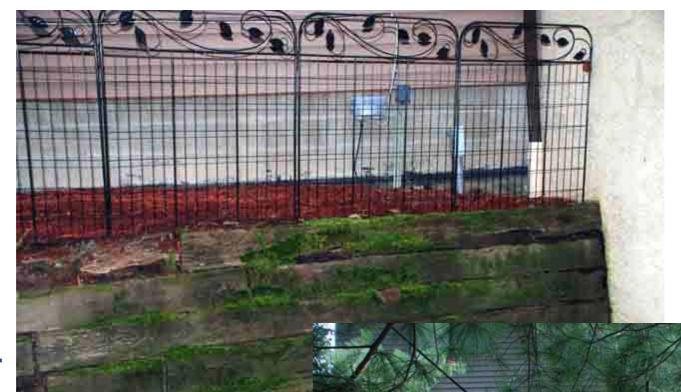
# Drainage

Extensive trimming of lower tree branches has improved air flow cross currents to reduce wet spots in treed areas.

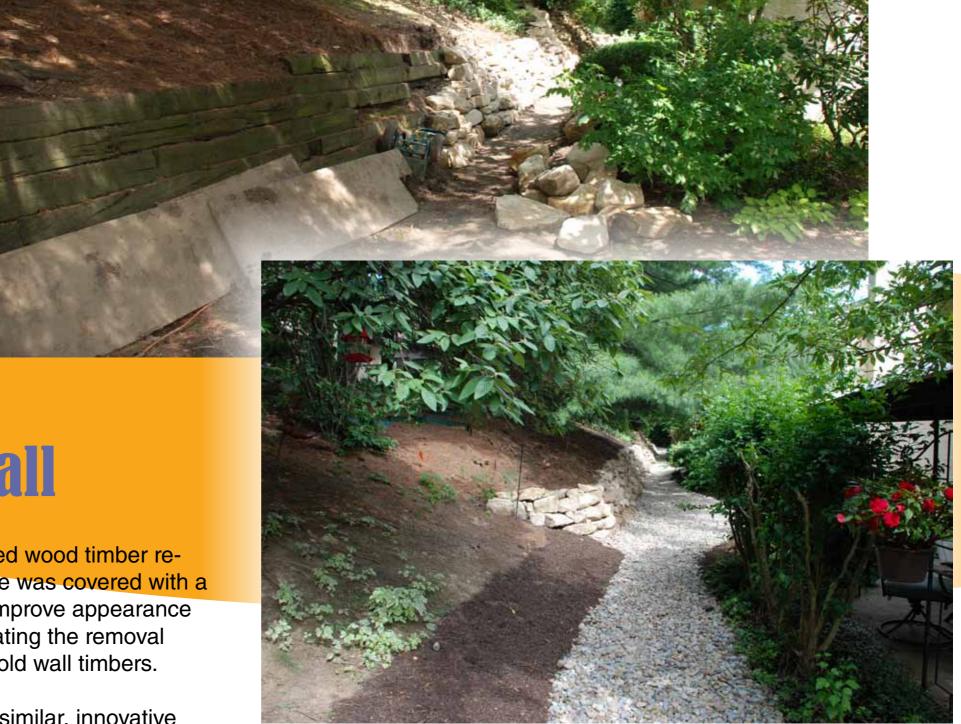
A drainage swale was added behind Olson Spur; many old dying trees and bushes were removed.

The large, badly deteriorated wood timber retaining wall above the swale was covered with a stacked boulder facing to improve appearance and drainage, while eliminating the removal costs for hauling away the old wall timbers.

We are currently exploring similar, innovative solutions to replace the rest of our original retaining walls.

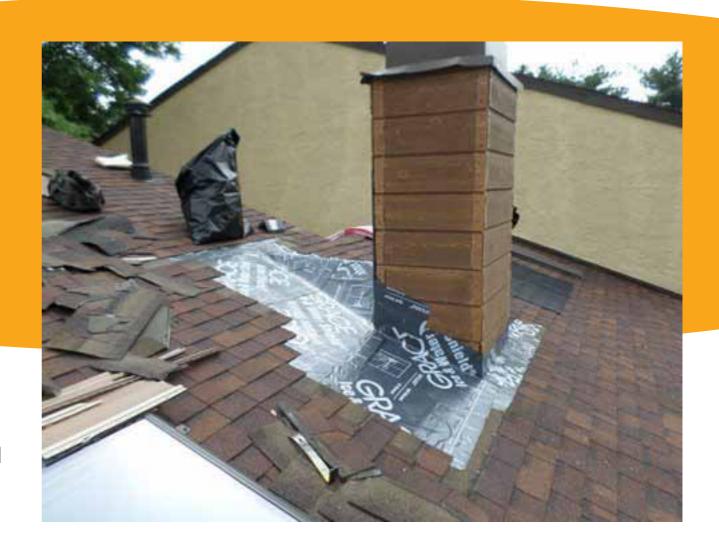
### Roofs

All units were re-roofed between 2006 and 2013.

Water-damaged roof sheeting was replaced before premium grade shingles and all new skylights were installed.

Unlike the original, substandard roofing installation, the new shingles were nailed over felt, and self-sealing ice guard membrane was installed six feet above all gutters, and in other critical areas.

A database record of all installations has been generated. At this writing, 28 roofs are still under warranty, some through 2018.

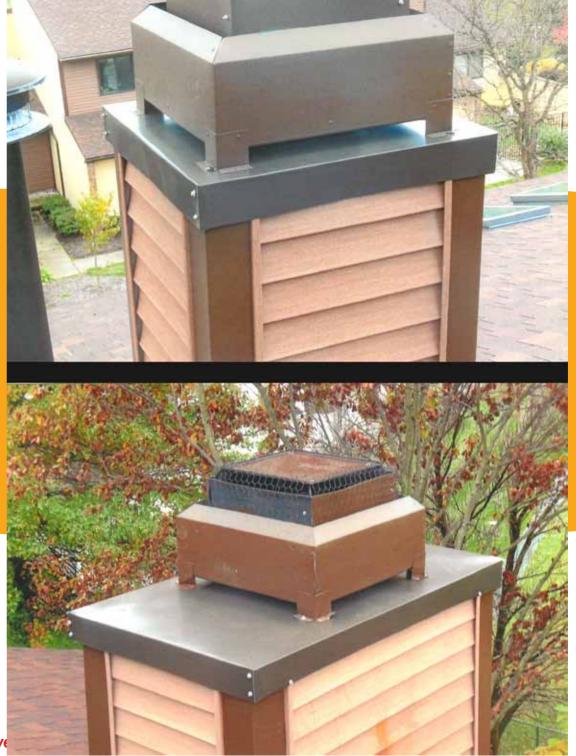
# **Chimney Caps**

# 34 chimney caps replaced in 2014-2015

Larger chimney pans were installed on several unit chimneys to provide more overhang for increased leak protection.

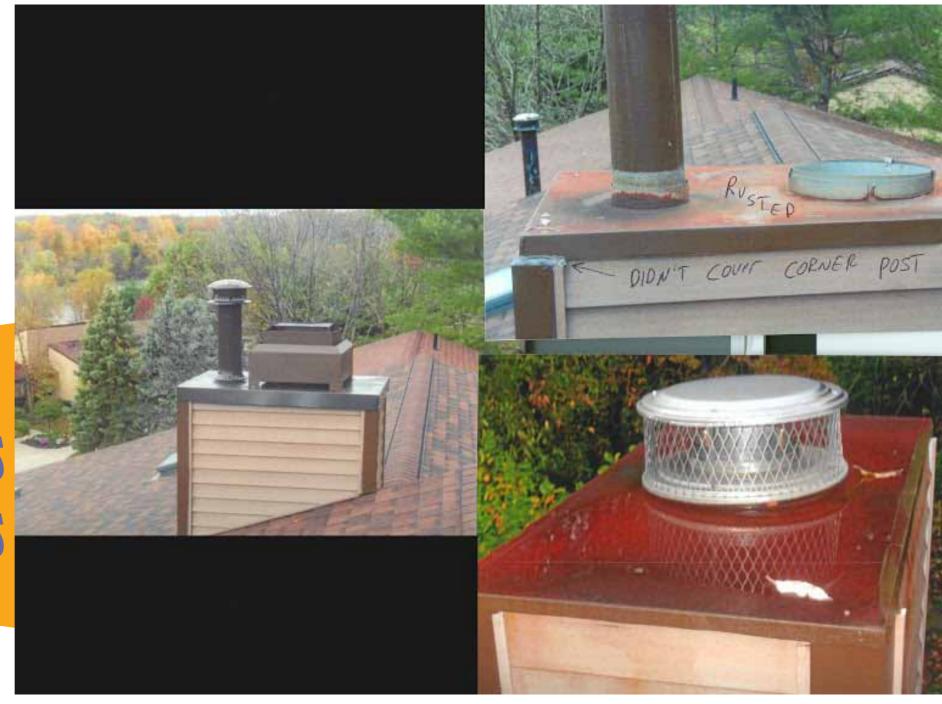
Chimney Caps and Pans

All chimney caps and pans were visually inspected within the past two years.

All caps and pans were either painted or replaced, as needed.

- association-wide inspection
- new database created to track condition for future inspection

A database has been created to note the dates of service/repair.

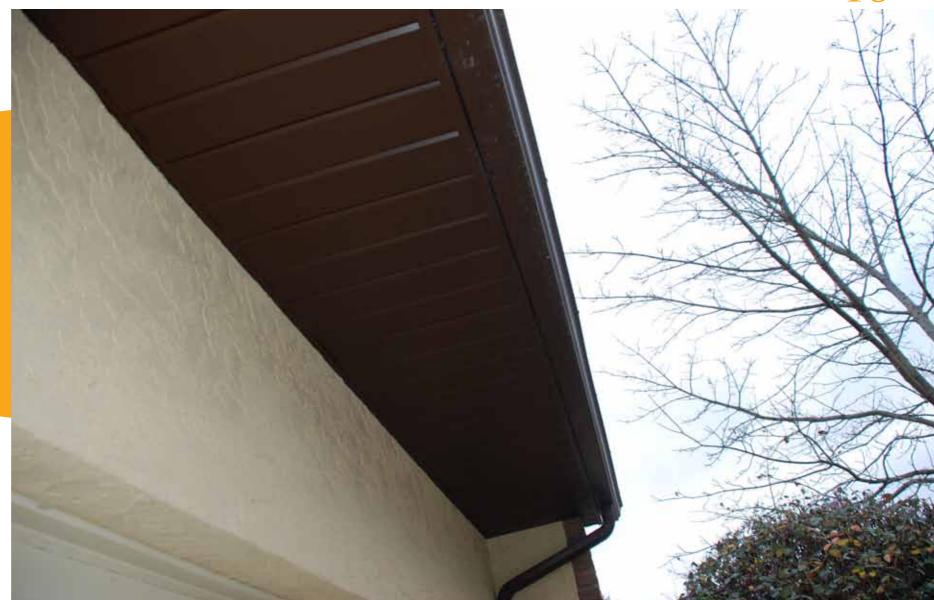
# **Gutters**

- Gutters are in good condition.
- In some instances, gutters have been re-hung to improve drainage pitch.

- Oversized gutters a have been installed on select units whose original four-inch gutter capacity proved inadequate during heavy rains.
- Note: All soffits and downspouts were repainted at the same time as the exterior wall stucco. Downspouts were removed for cleaning and painting before being re-hung.

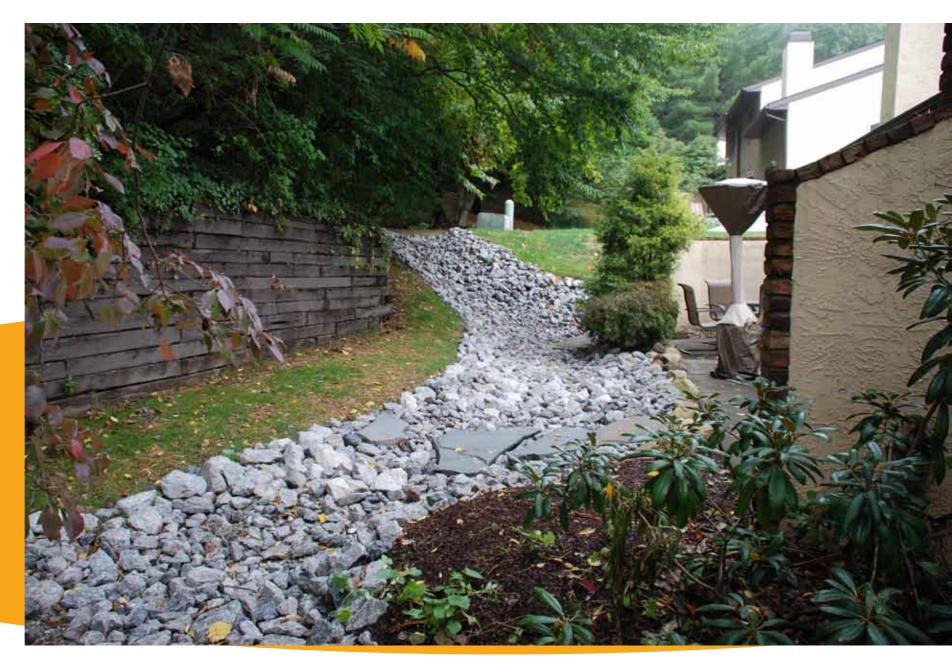
Drainage

In 2015, an oversized swale/spillway was installed on Lake Terrace Drive. This was necessitated by extremely heavy stormwater runoff from adjacent property that exceeded the capacity of the original drain.

The association and city are discussing ways to mitigate this problem.

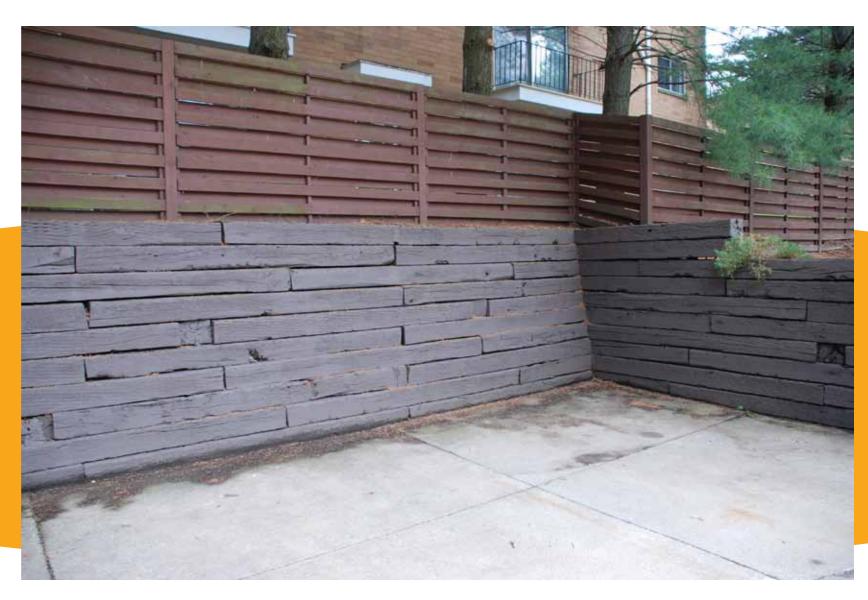
# Retaining Walls

Three timber retaining walls were power washed and stained (2014-2015).

Volunteers will stain the privacy fence (photo right) on in 2016.

Three very short retaining "walls" have been removed entirely, and adequately replaced by grading and planting or mulching of the surrounding area.

We are currently in the process of estimating replacement costs for the remaining retaining walls. In addition to the cost of possible timber replacement, we are also exploring the price of re-facing the existing timber walls with poured concrete. The second option may reduce both installation and long term maintenance costs, and saves the expense of removing the old timbers, which will simply that store oil behind the concrete veneer.

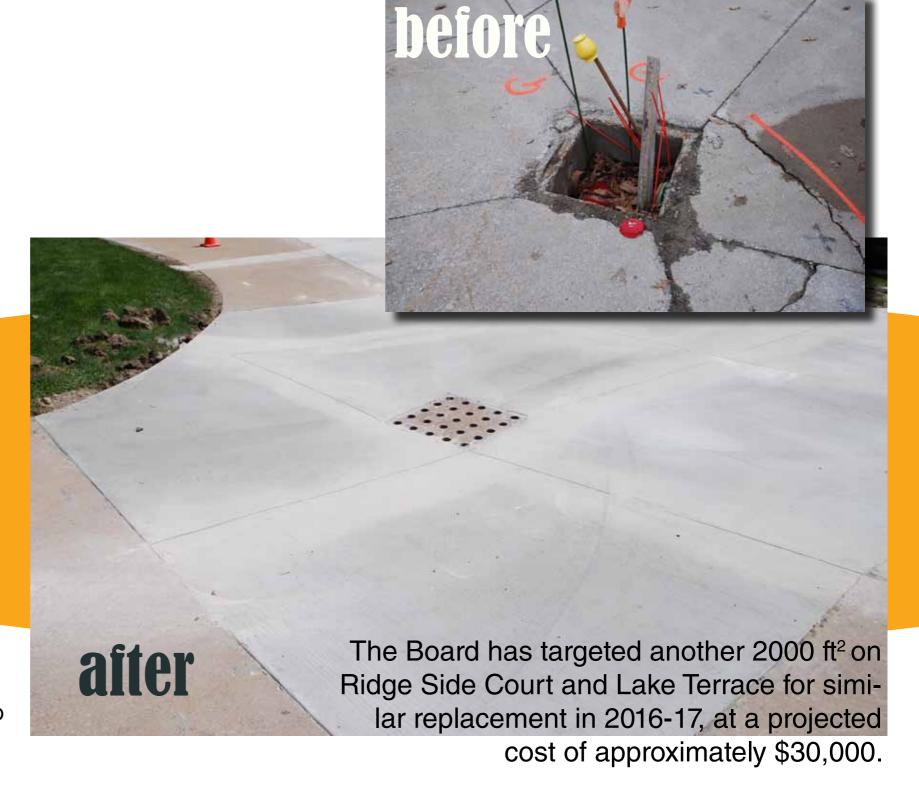
# **Concrete**

streets and drives replaced on SVB, RSC, and OS

In 2014 and 2015, over 12,000 square feet of street and driveway surface was replaced.

Several street drain boxes were also replaced to improve function and strength.

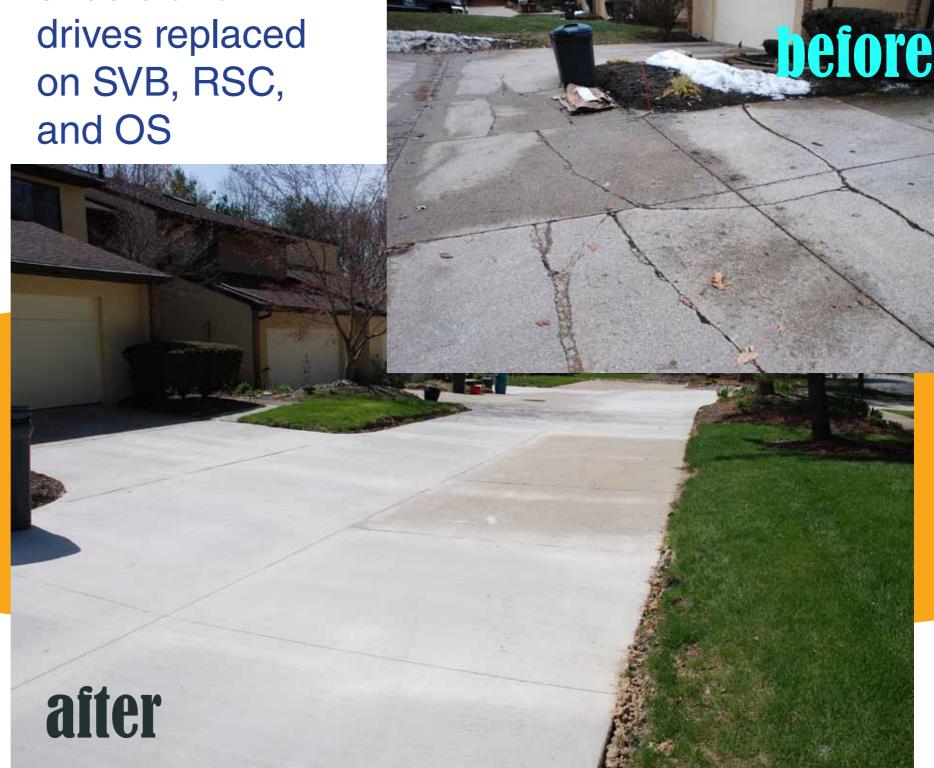
# **Concrete Silver Valley**

All poured concrete was highway grade mix, properly reinforced with steel mesh. New sections pinned to old for stability.

We feel that the concrete repairs and related drainage improvements completed in 2014 should last for many years to come.

- Concrete work complete on all sections of SVB.
- Apron repairs RSC 2017 \$8300/~550 ft<sup>2</sup>
- Apron repairs Olson Spur 2017 \$9700/~650 ft<sup>2</sup>
- Major repairs in multiple areas of LTD 2016 \$19,500/~1500 ft<sup>2</sup>
- Small work on Mulberry 2017 completion \$6500/~410 ft<sup>2</sup>

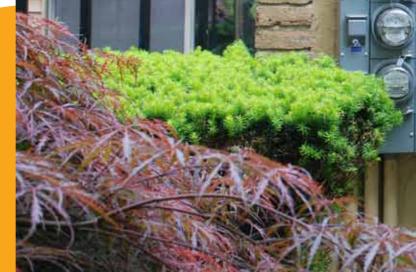
# **Electrical Boxes**

entire unit box replaced on SVB

All electrical boxes were inspected in the last two years, and with one exception, all are in good shape.

The one exception: a severely damaged box on SVB was replaced in 2014.
