# FULL RESERVE STUDY

## Silver Valley Condominium, Inc.

**Munroe Falls, Ohio**

**April 14, 2016**

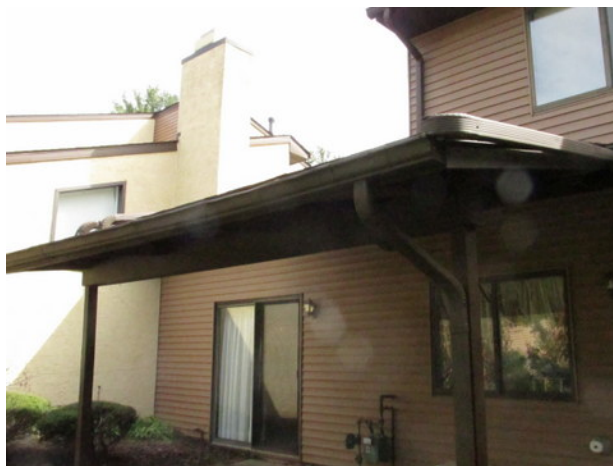
**Gutters and Downspouts, Aluminum** - Approximately 18,000 linear feet of aluminum gutters and downspouts drain storm water from the roofs of Silver Valley. The Board informs us approximately 9,000 linear feet of gutters and downspouts were replaced from 2012 through 2015. These gutters and downspouts are in good to fair overall condition. Approximately 9,000 linear feet of gutters and downspouts are original and in fair condition. The Board informs us the gutters and downspouts were recently inspected and the downspouts were painted in conjunction with stucco paint finish applications. The gutters and downspouts exhibit damage.

**Typical gutter and downspout configuration**

2024, in conjunction with stucco paint finish applications. A subsequent phased replacement of these gutters and downspouts is likely beginning by 2041 and concluding by 2044. We depict this information on Line Items 1.240 and 1.241 of *Reserve Expenditures*. We base our cost on replacement with .027-inch thick aluminum.

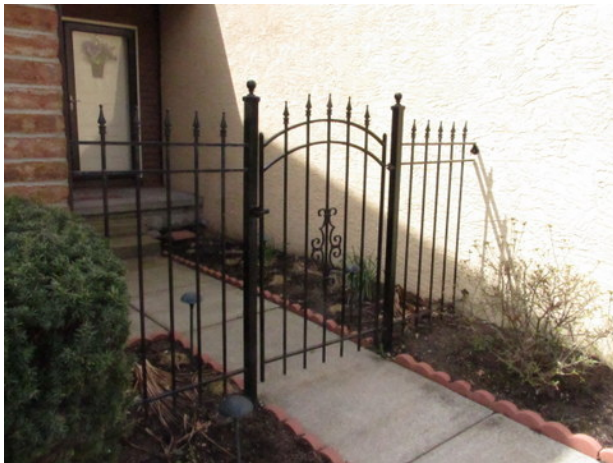
**Railings and Gates, Metal** - The Association maintains approximately 765 linear feet of metal gates and railings at various unit entrances. Approximately 100 linear feet of metal gates and railings were replaced in 2015 or will be replaced in 2016. See “**Staircases**” for our inclusion of this cost. The remaining gates and railings are likely original and in fair condition with isolated sections in poor condition. The gates and railings exhibit rust and paint finish deterioration.

**Metal gate overview**

Periodic applications of paint to the metal will maximize the useful life. Preparation of the metal before application of the paint finish is important. The painting contractor should remove all soil, dirt, oil, grease and other foreign materials before application of the paint finish to maximize its useful life. The contractor should also remove paint blisters and rust prior to the paint finish application. We recommend the use of a power wire brush, scraper and/or sander as effective means of removal. The Association should require the application of a primer on bare metal. The primer for metal surfaces should include a rust inhibitor for added protection. We recommend the Association budget for paint applications to the metal gates and railings by 2029 and every eight years thereafter. We anticipate the need to replace the remaining gates and railings replacement by 2021. We do not anticipate the need for replacement of the metal railings and gates replaced in 2015 and 2016. We depict this information on Line Items 1.243 and 1.244 of *Reserve Expenditures*.

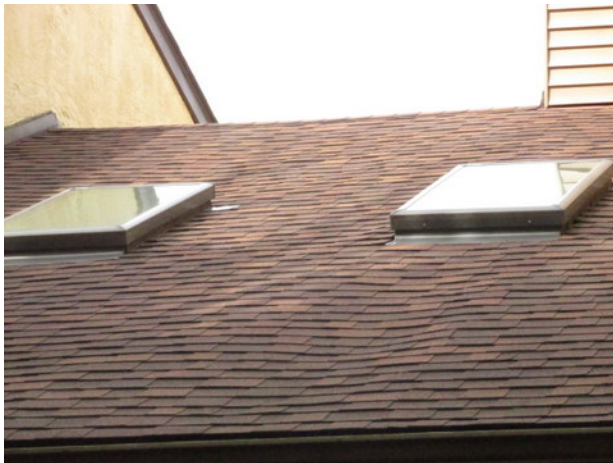
**Roofs, Asphalt Shingles** - Approximately 1,825 *squares*<sup>1</sup> of asphalt shingles comprise the roofs of Silver Valley. The roofs were replaced from 2006 through 2014 and are in good to fair overall condition. Our visual inspection from the ground notes sheathing deflection and asphalt shingle lift.

**Minor sheathing deflections near skylight at Unit 76**

Based on the age and condition of the roofs, we recommend Silver Valley budget for a phased replacement beginning by 2026 and concluding by 2034. A subsequent phased replacement is likely beginning by 2046. We note this information on Line Item 1.280 of *Reserve Expenditures*. We base our cost on replacement with standard laminate Class A 240-260-pounds per square shingles. The Association should fund any repairs prior to the complete replacement of the roofs through the operating budget. Our estimate of cost includes removal and reattachment of the gutters and downspouts at the time of replacement.

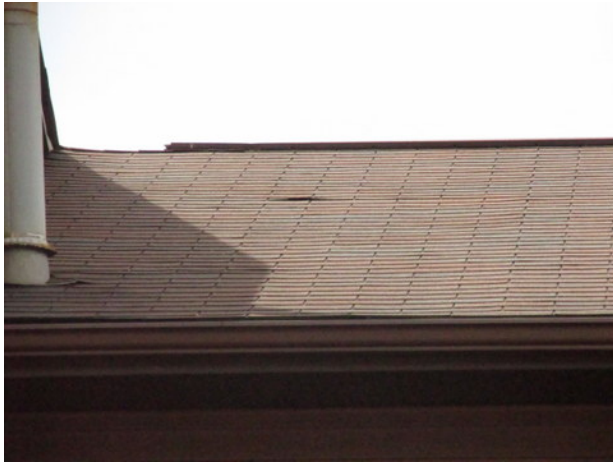
**Minor asphalt shingle lift**

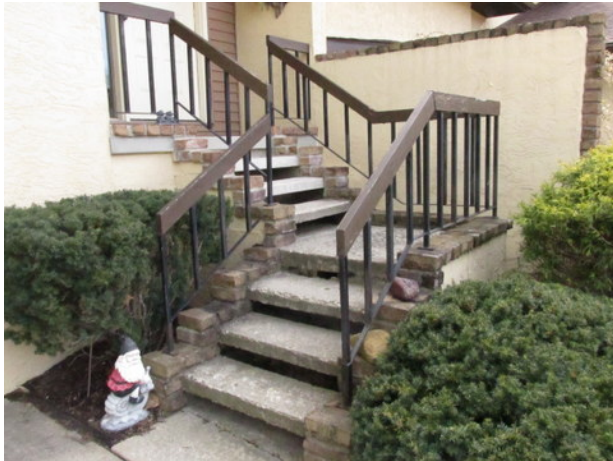
**Staircases** - The Association maintains 28 sets of concrete staircases with decorative brick masonry and metal railings. See “**Railings and Gates, Metal**” for our recommendations on replacement of the metal railings. The staircases are mostly original and in fair overall condition. The Board informs us four staircases were repaired in 2015. The Board also informs us the Association plans to repair or replace concrete treads and railings with deterioration in 2016. We note concrete cracks, concrete deterioration, brick mortar deterioration, organic growth and stucco paint finish deterioration at the staircases.

**Staircase overview**

The Association should anticipate subsequent inspections and partial replacements every five years thereafter. We include this information on Line Item 1.600 of *Reserve Expenditures*. Partial interim replacements should be funded through the operating budget as normal maintenance. The estimate of cost in 2016 reflects a cost provided by the Board.

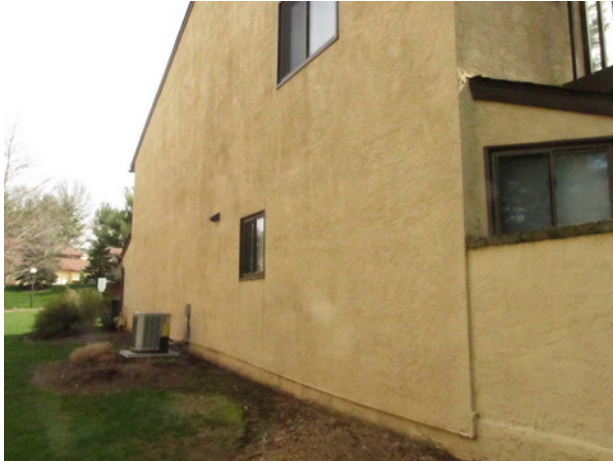
**Walls, Stucco** - Stucco comprises one of the exterior finish materials at the buildings and privacy walls. The stucco is original and in fair overall condition. The Board informs us the stucco paint finish at the buildings was reapplied from 2011 to 2014 and it is in good to fair overall condition. We note stucco cracks, deterioration and paint finish deterioration.

**Stucco overview**

We depict this information on Line Item 1.861 of *Reserve Expenditures*. The estimate of cost reflects historical costs provided by the Board plus partial sealant replacements.

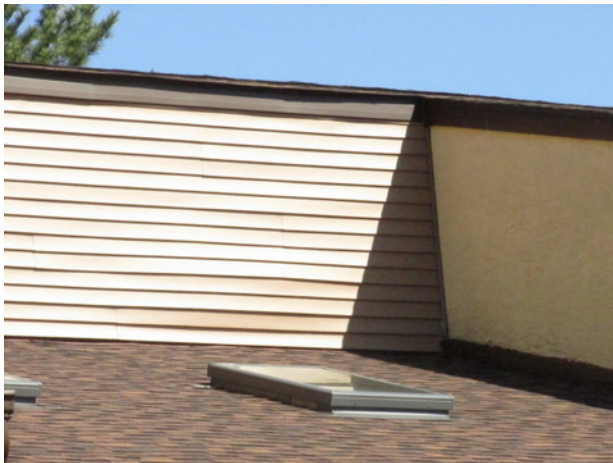
**Walls, Vinyl Siding** - Vinyl siding comprises approximately 77,000 square feet of the exterior walls. This quantity includes the aluminum soffit and fascia. The Board informs us the vinyl siding was installed from 2004 to 2005 and it is in good to fair overall condition. We note vinyl siding solar warp and heat warp adjacent to windows and skylights.

**Vinyl siding warp at Unit 94**

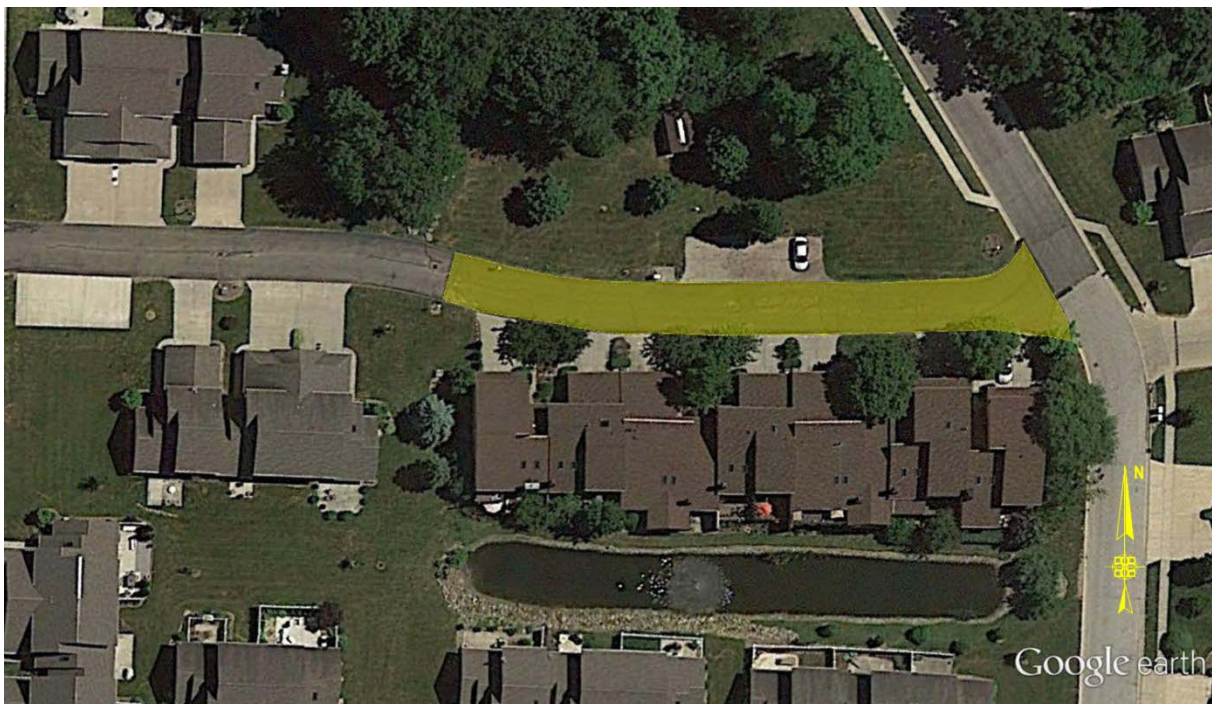
**Asphalt Pavement, Repaving** – The Association is responsible for thirty percent (30%) of costs associated with the 650 square yards of asphalt pavement along Mulberry Lane. The following figure depicts the location of the asphalt pavement along Mulberry Lane:

The pavement is in poor overall condition at an unknown age. The Board informs us the Association conducted pavement repairs in 2014. The Association should continue to fund crack repairs and patching as ongoing maintenance through the operating budget. We note cracks, previous repairs, partial replacements and minor catch basin settlement.

times in the past or where the configuration makes overlayment not possible. Based on the apparent visual condition and configuration of the asphalt pavement, we recommend the mill and overlay method for initial repaving followed by the total replacement method for subsequent repaving at Silver Valley.

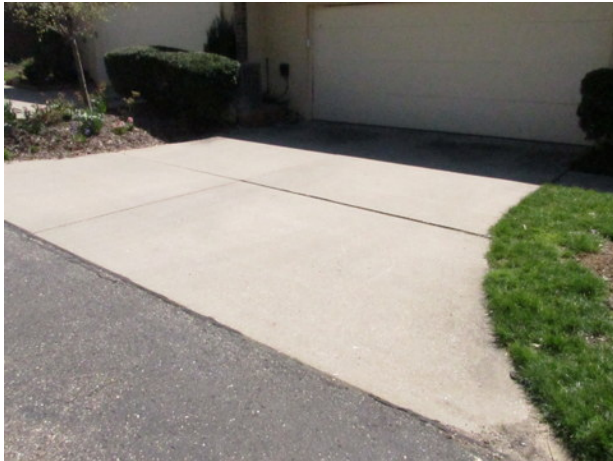
*Concrete Driveways* - Concrete driveways of varying sizes and configurations allow for access to the individual residences throughout the Association. The driveways are in fair overall condition and comprise approximately 38,700 square feet. We note cracks, settlement and partial replacements.

**Concrete driveway near Mulberry Lane**

We estimate that up to approximately 11,620 square feet of concrete driveways, or thirty percent (30%) of the total, will require replacement during the next 30 years. We advise the Association budget for the replacement of up to approximately 1,660 square feet by 2023, followed by a steadily increasing rate of replacement as the driveways continue to age.

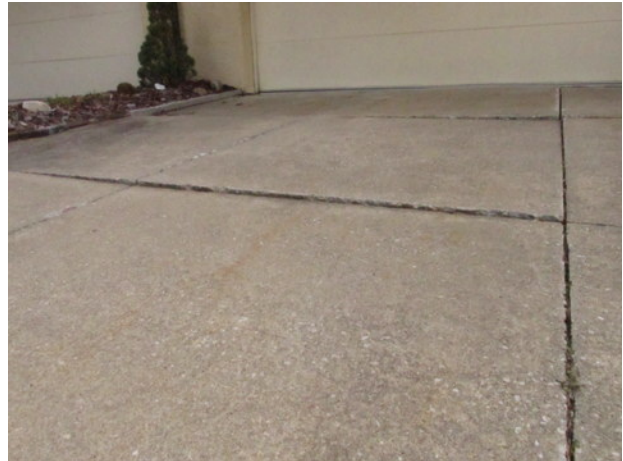
**Concrete driveway settlement**

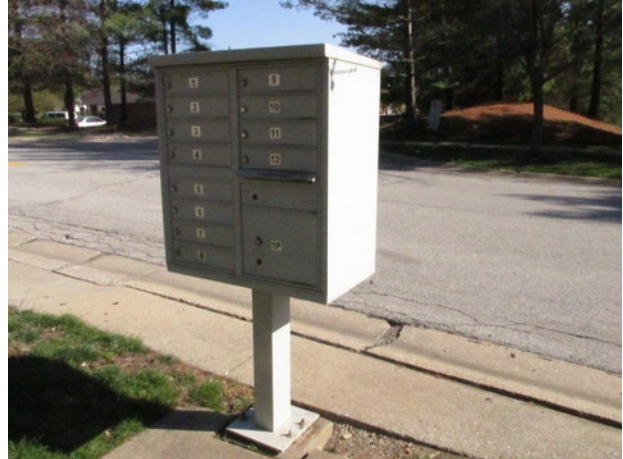
**Typical mailbox station**

Mailbox stations of this type have useful lives of up to 25 years. Silver Valley should budget for replacement of the mailbox stations by 2020 and again by 2042. We depict this information on Line Item 4.600 of *Reserve Expenditures*. The Association should verify the new mailboxes meet the specifications of the *United States Postal Service*.

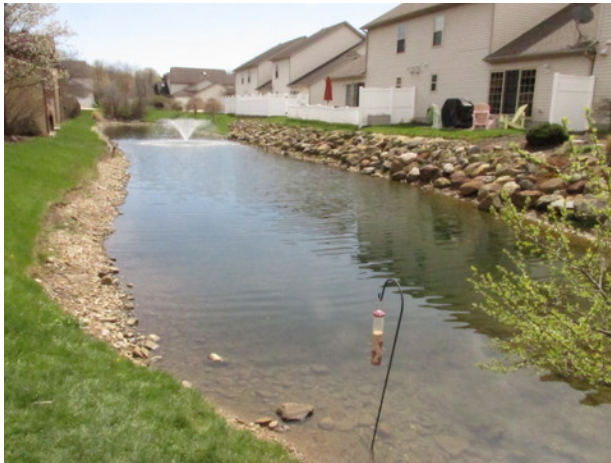
**Pond overview**

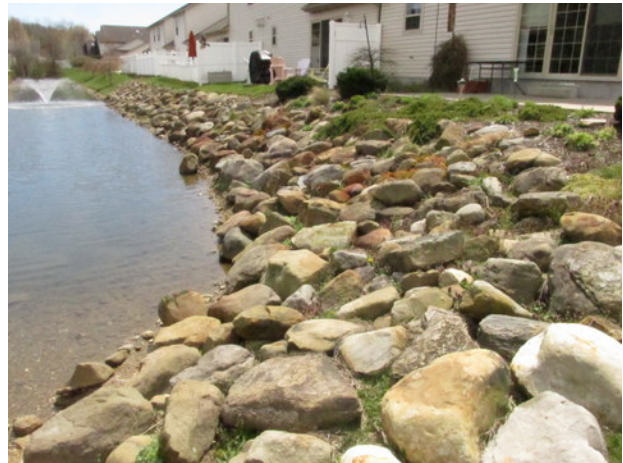
**Pond shoreline rip rap**

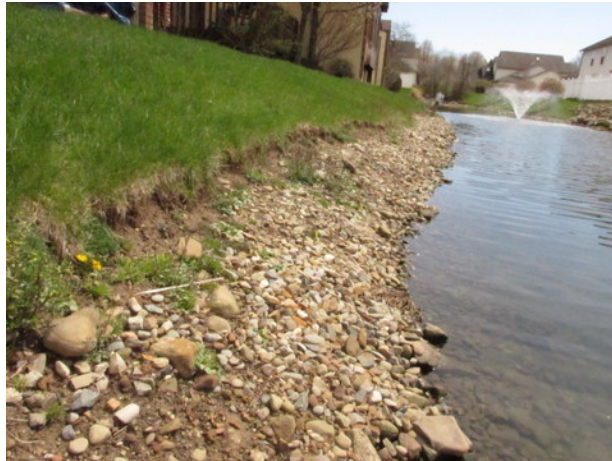
**Pond** - The Association funds fifty percent (50%) of the maintenance costs for the retention pond south of Mulberry Lane. The remaining maintenance costs are funded by the neighboring association. The health or condition of a pond is reflected in the clarity of the water, balance of plant life, the ability of the water to retain life giving gases and the health of the fish in larger bodies of water. Three factors which affect the health of ponds are erosion, buildup of silt and algae blooms. We note erosion along the northeast perimeter of the pond.

**Pond shoreline with minor erosion**

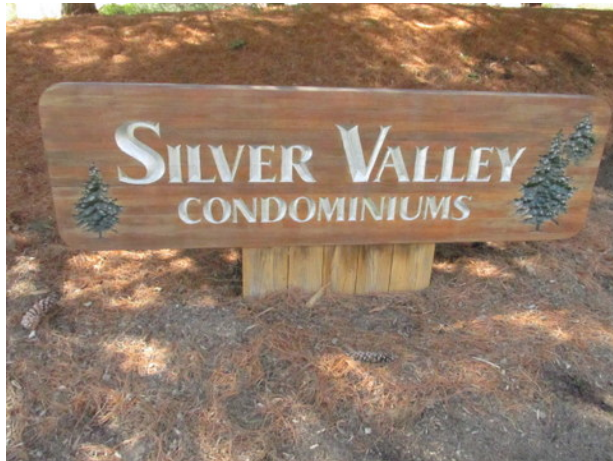
**Signage, Renovation** - The Association maintains five wood and four painted concrete property and unit identification signs throughout the community. The Board informs us the signs were painted and cleaned in 2014. The signage is likely original and in fair overall condition.

**Wood property identification signage**

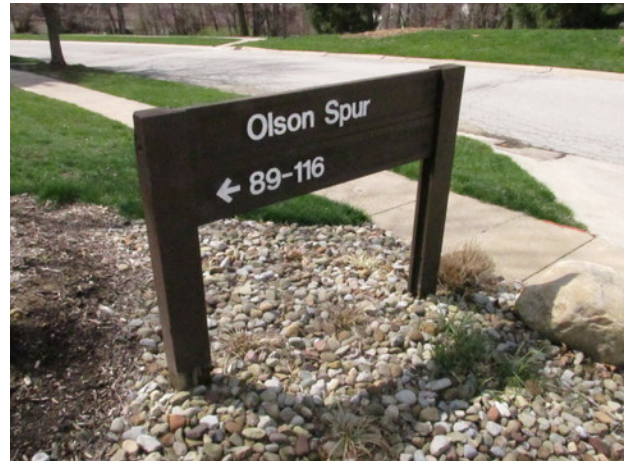
**Wood street and unit identification signage**
